March 13, 2018
Our File: 518014

Re: Mollard Line Culvert
Structure No. 1056
Emergency Closure

Appendix 'A' - Existing Conditions Photos

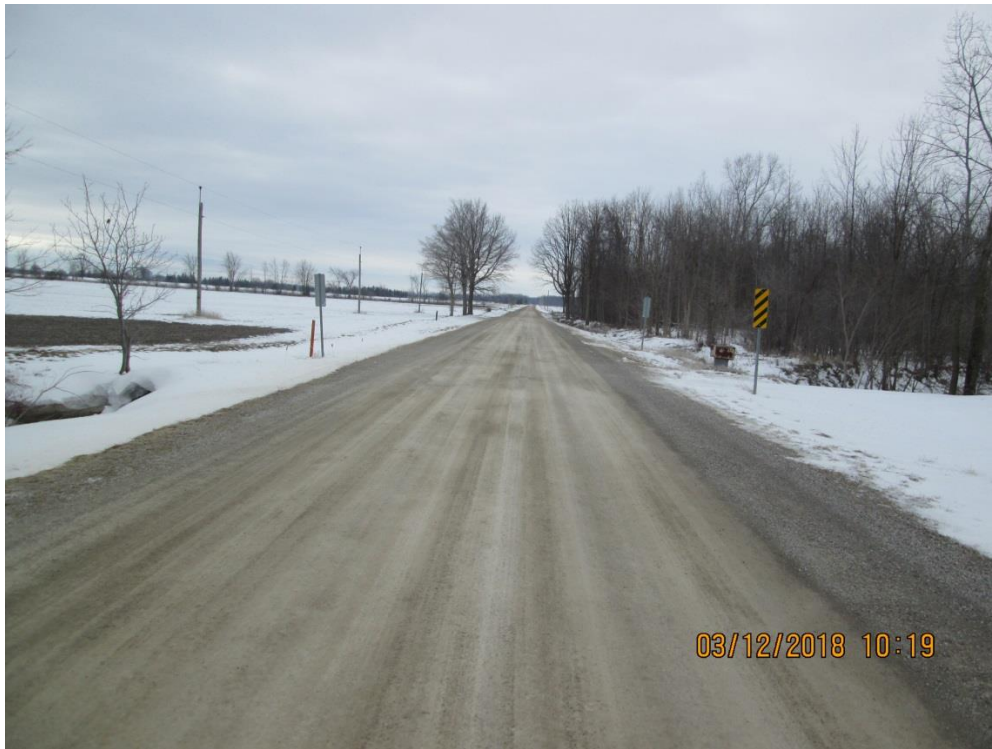
Plan view, facing south

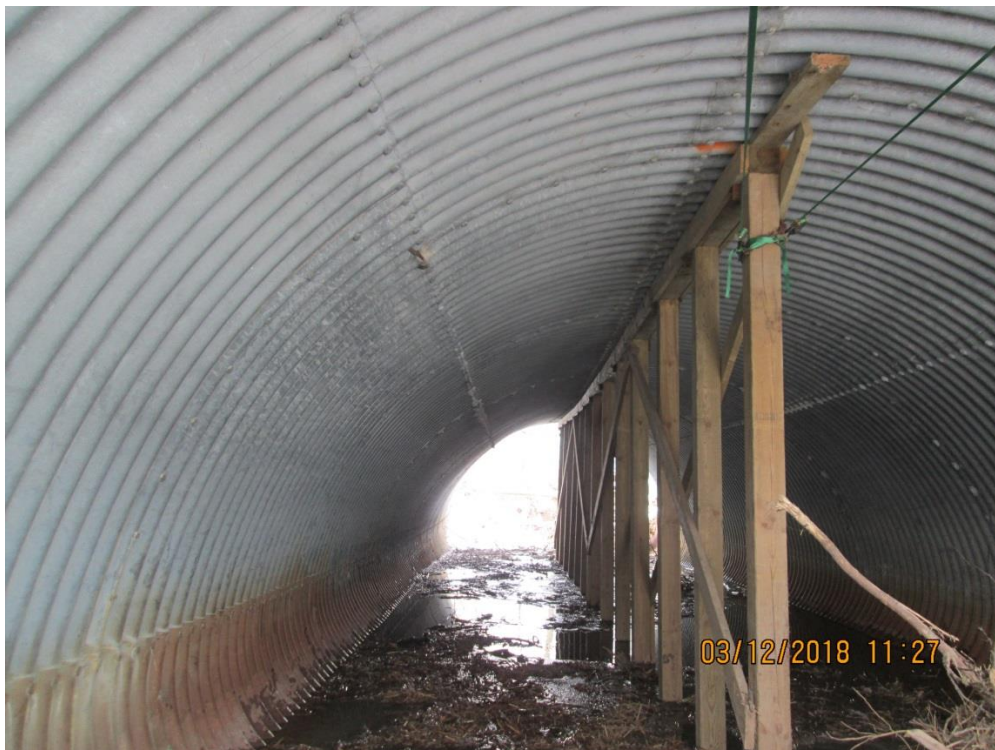
East end of structure, facing west

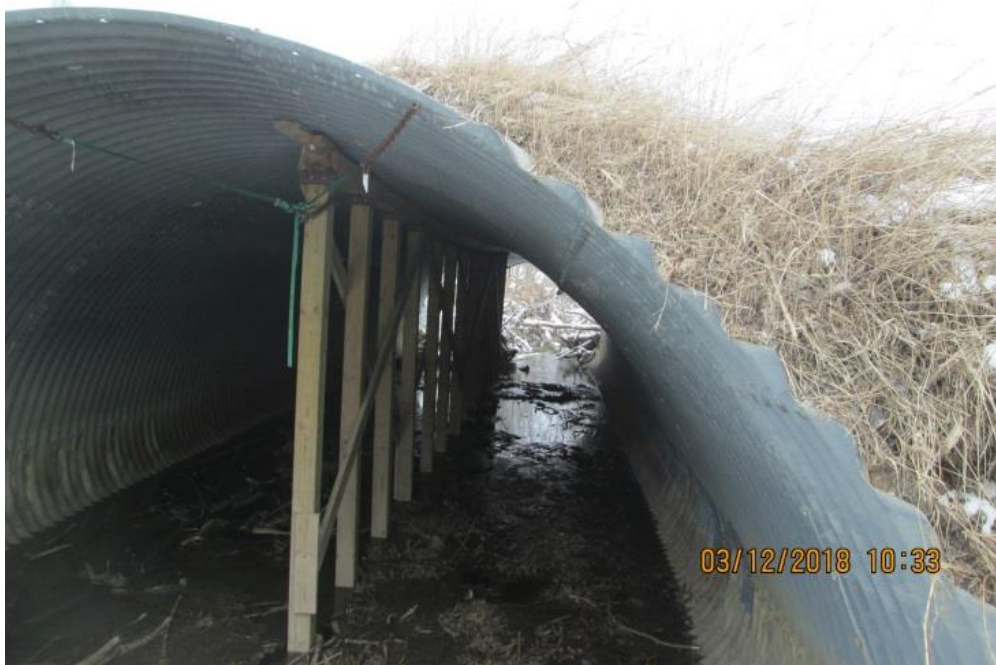
West end of structure, facing east

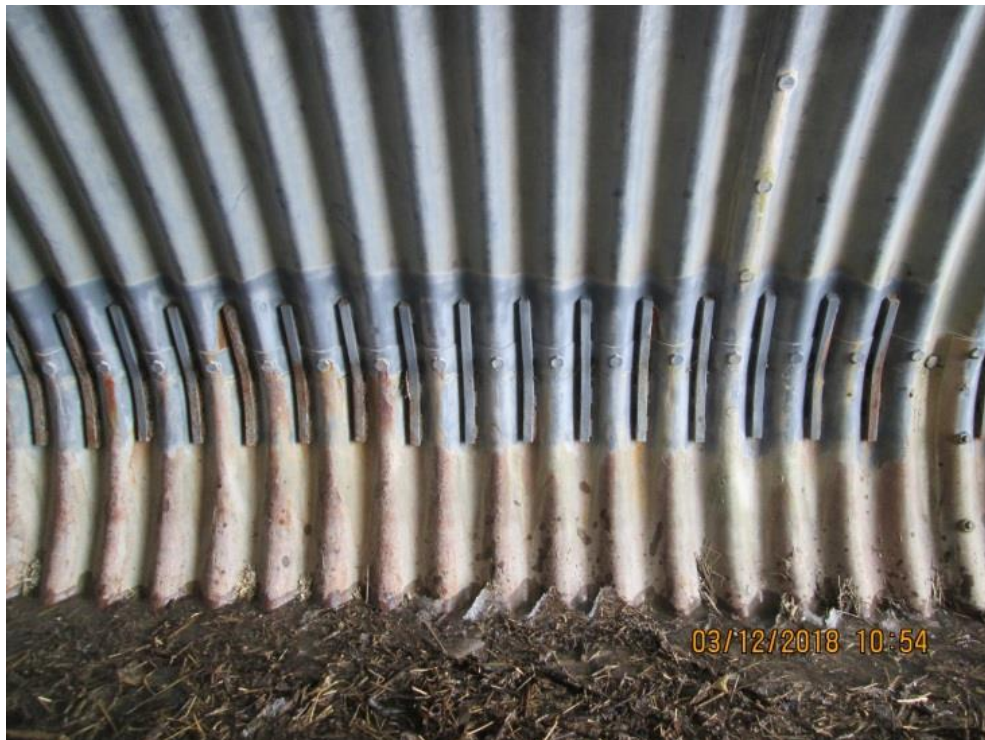
Crack reinforcement along south side of structure

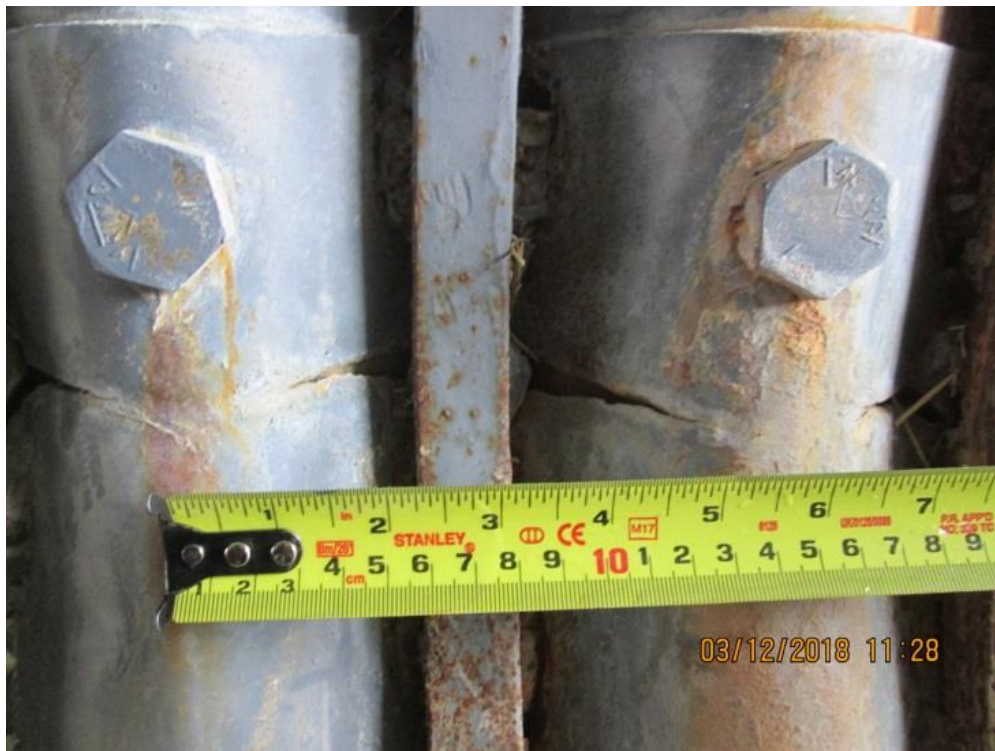
Based on the site observations, and upon comparing the observations to the 2013 and 2015 OSIM reports, we feel that the deformation on the obvert and below the obvert position on the south wall of the structure and the severe springline cracking are of significant structural concern. We recommend that the structure be closed to all traffic until an appropriate replacement strategy is designed and implemented.

Cracking at springline along south side of structure

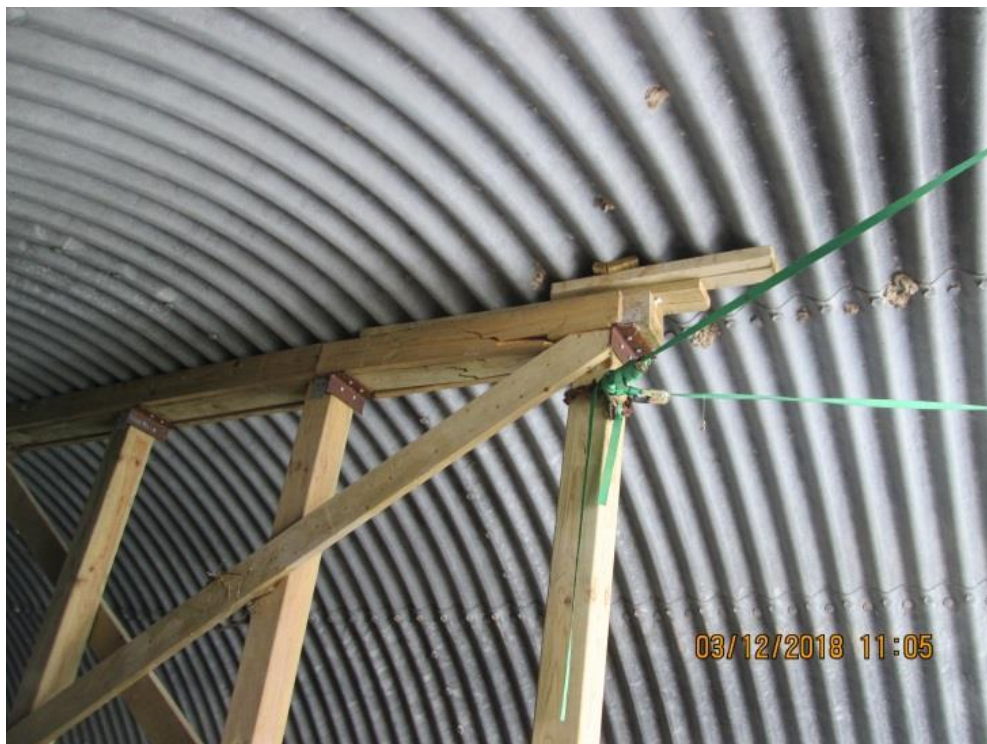
Timber bracing displaying cracking/splitting
