**B. M. ROSS AND ASSOCIATES LIMITED**  
**Engineers and Planners**  
62 North Street, Goderich, ON N7A 2T4  
p. (519) 524-2641 • f. (519) 524-4403  
[www.bmross.net](http://www.bmross.net)

File No. 82071A

**RE: Storage Shed at the West end of the Huron Park Arena**

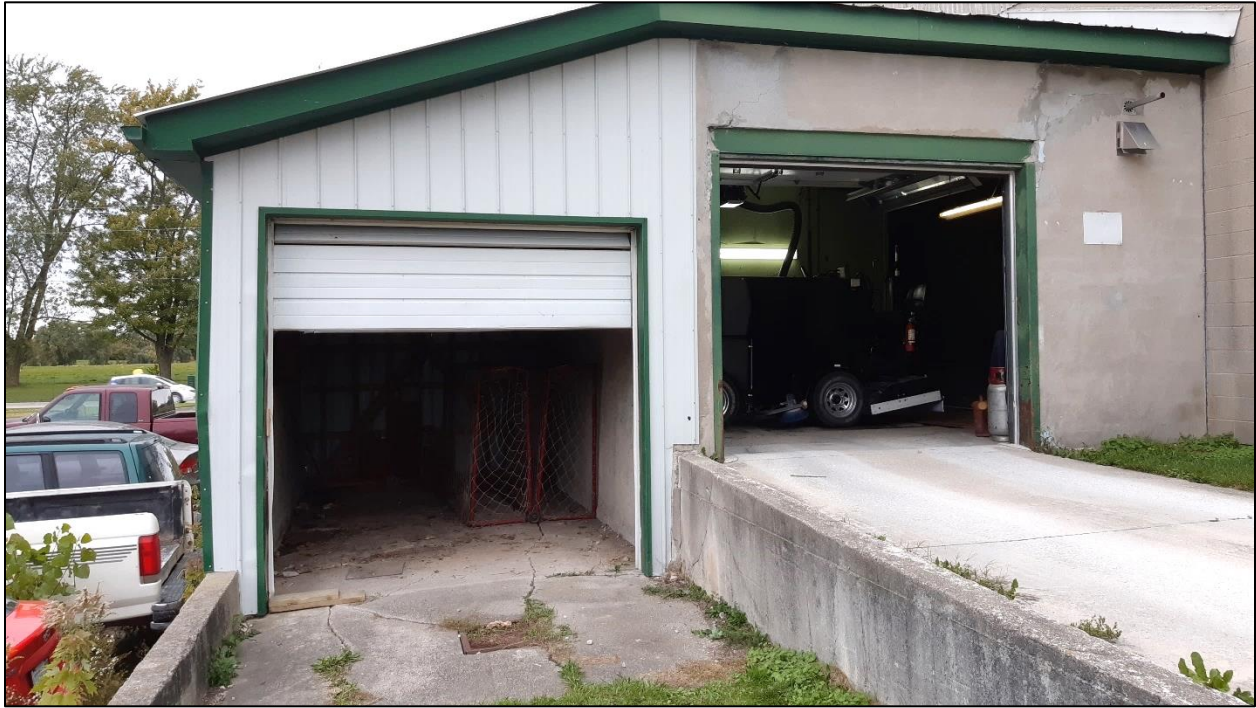
**East Elevation**

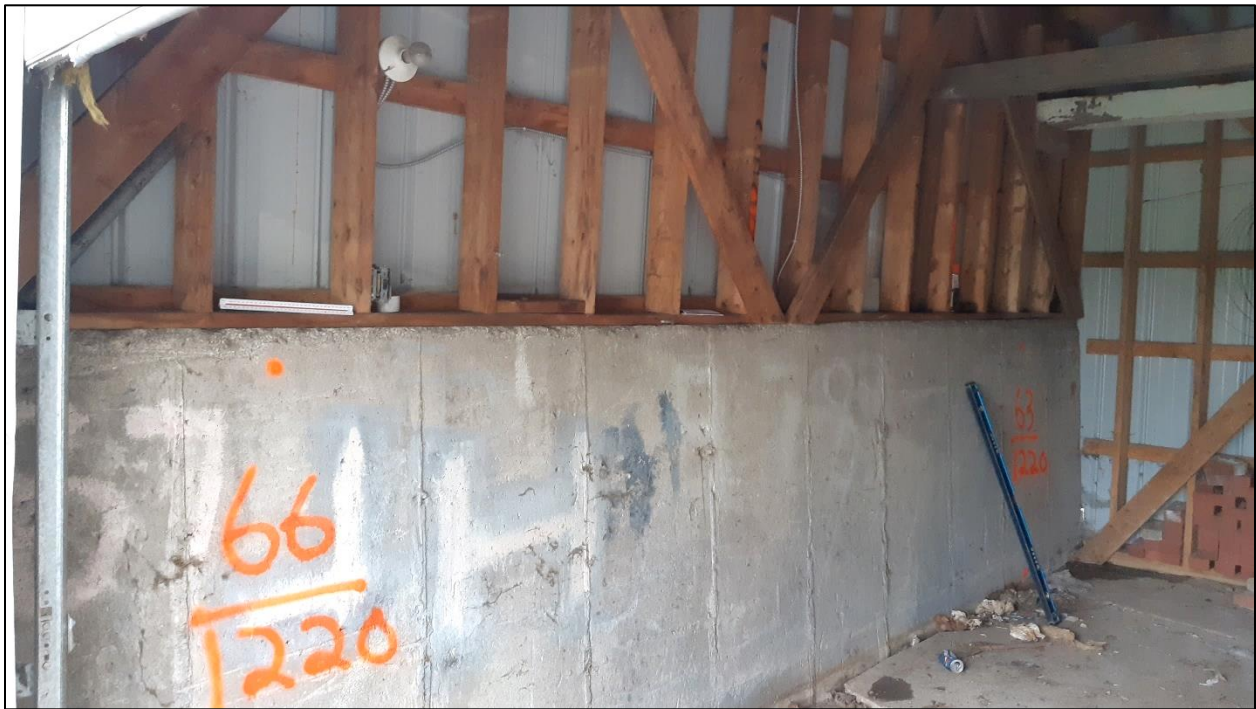
**Cracked Retaining Wall – Olympia Room**

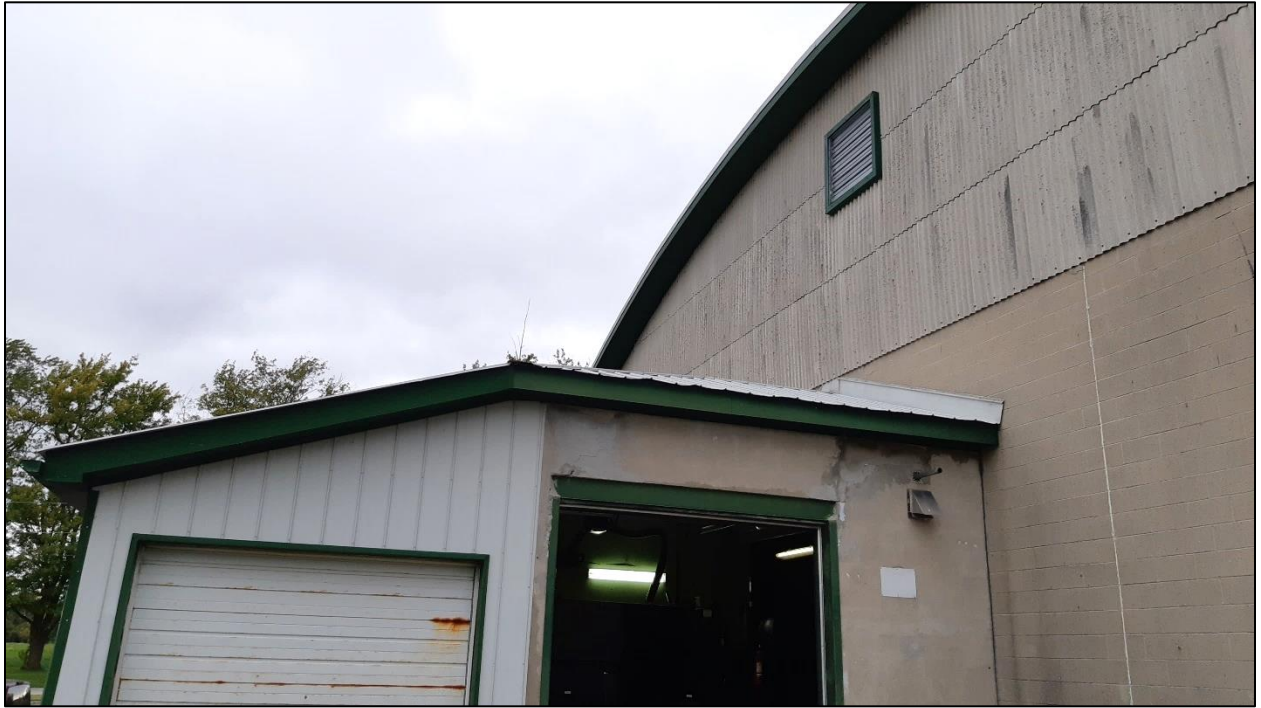
The overall misalignment of the west shed wall is cause for concern, particularly if staff feel that the movement has happened after the shed framing was constructed. The wall is a load bearing wall and there is a large elevation difference between the shed roof and the arena roof, making the roof susceptible to increased loads from snow drifting.

**Height Differential between Shed/Olympia Room and Arena**

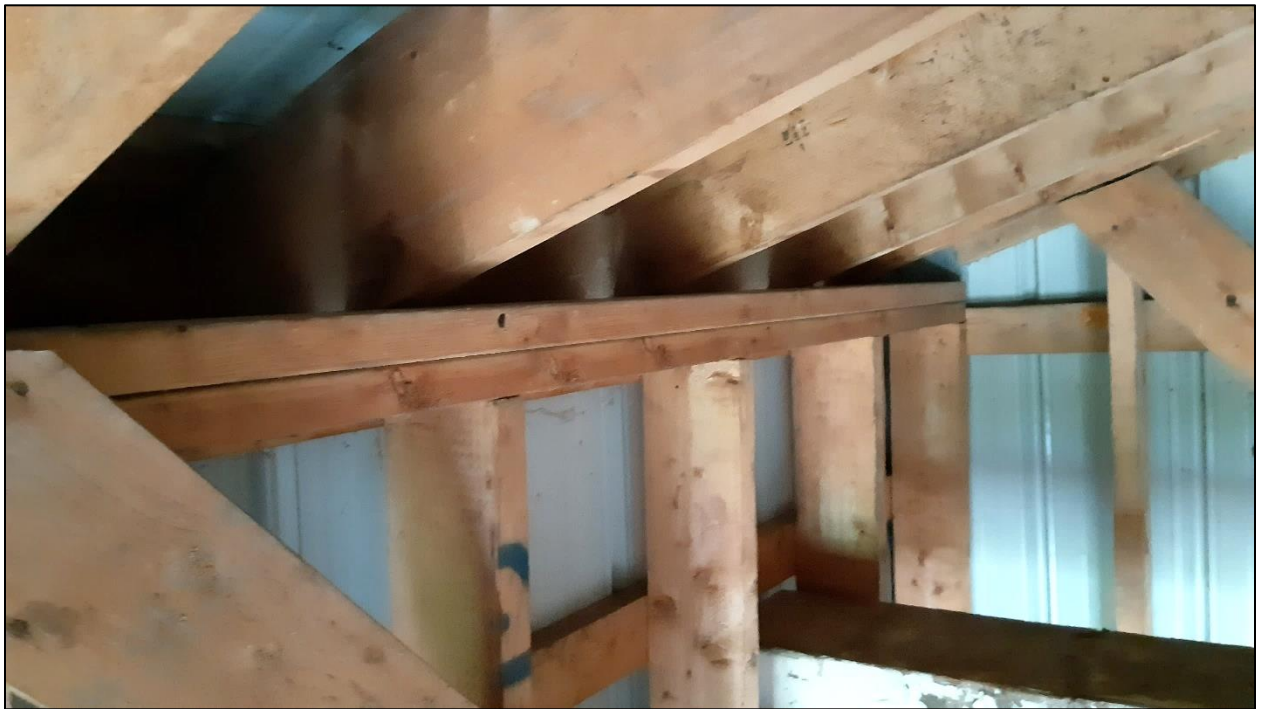
**Roof Framing**

We recommend providing a positive connection between the top of the foundation wall and the bottom of the stud wall, and between the top of the stud wall and the rafters. An example for improvements is included in Appendix 2. However, staff or a builder, may have some more practical means for improvements.
