B. M. ROSS AND ASSOCIATES LIMITED
Engineers and Planners
62 North Street, Goderich, ON N7A 2T4
p. (519) 524-2641 • f. (519) 524-4403
www.bmross.net

July 11, 2012

RE: Structural Review of the South Huron Recreation Centre

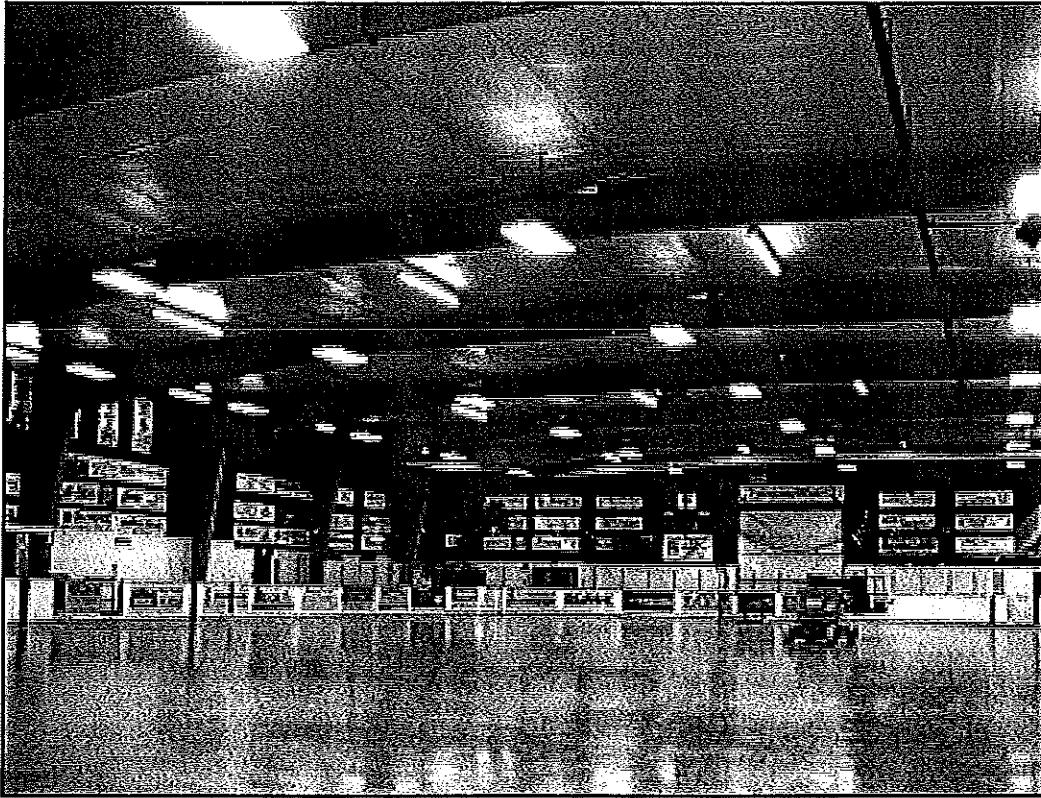
The arena is a steel rigid frame building with tapered columns and beams. The columns are connected to the beams with bolted moment connections. The three sections of beam are connected together with bolted connections also. Steel purlins span between the rigid frames at close spacing. Review of the arena roof structure was assisted by use of a hydraulic, portable lift. As reported in 2007, the view was obstructed by low-E fabric over the entire rink surface and puck netting at each end of the rink. It was still possible to pull back the fabric in some places and view the purlin-to-girder connection but the overall condition of the purlins was not available to be observed. Hands-on inspection of the purlins and top flanges of the beams was not achievable for most of the roof structure. Despite this, we were satisfied that the roof is in good condition.

Arena Facing North

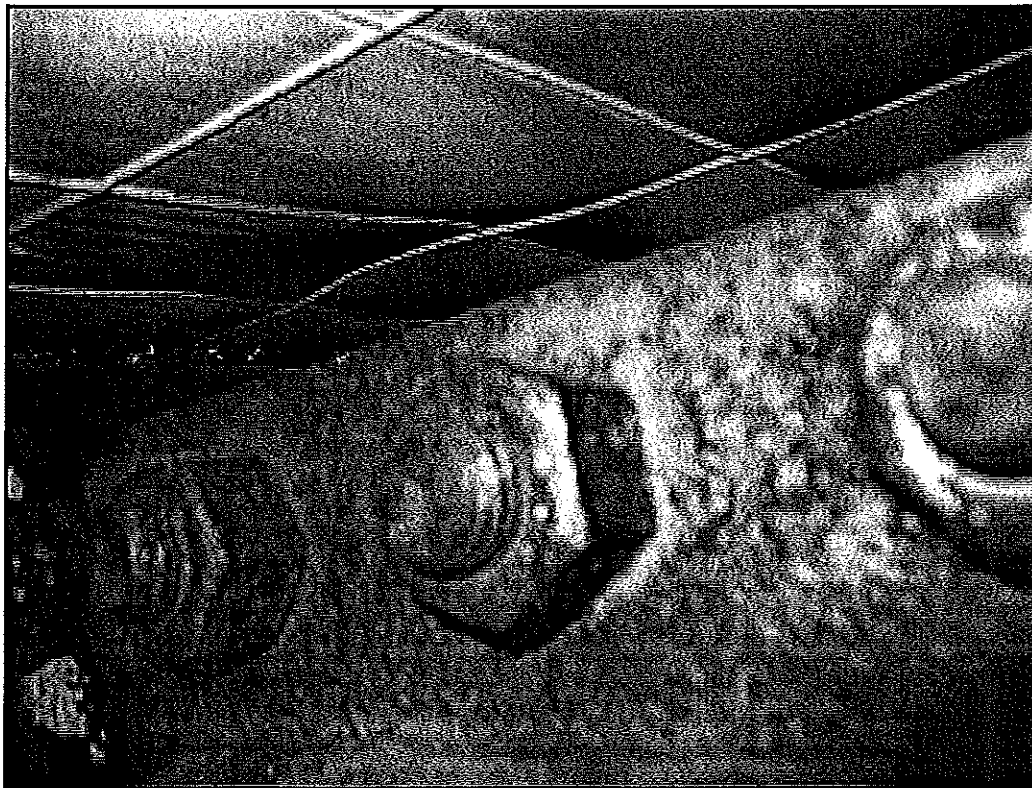
We understand that the steel structure was painted in 2003. There are some minor paint failures and localized rusting on the top flange and at many of the bolts that connect the top flanges together. However, this deterioration is superficial and is not significant to the structure at this time.

Bolts at Top of Beam

- Re-paint the structural steel framing over the ice surface
- Replace bolts in the top flange connections
- Replace the roofing membrane over the ice surface
- Replace the roofing system over the community centre (likely twice)

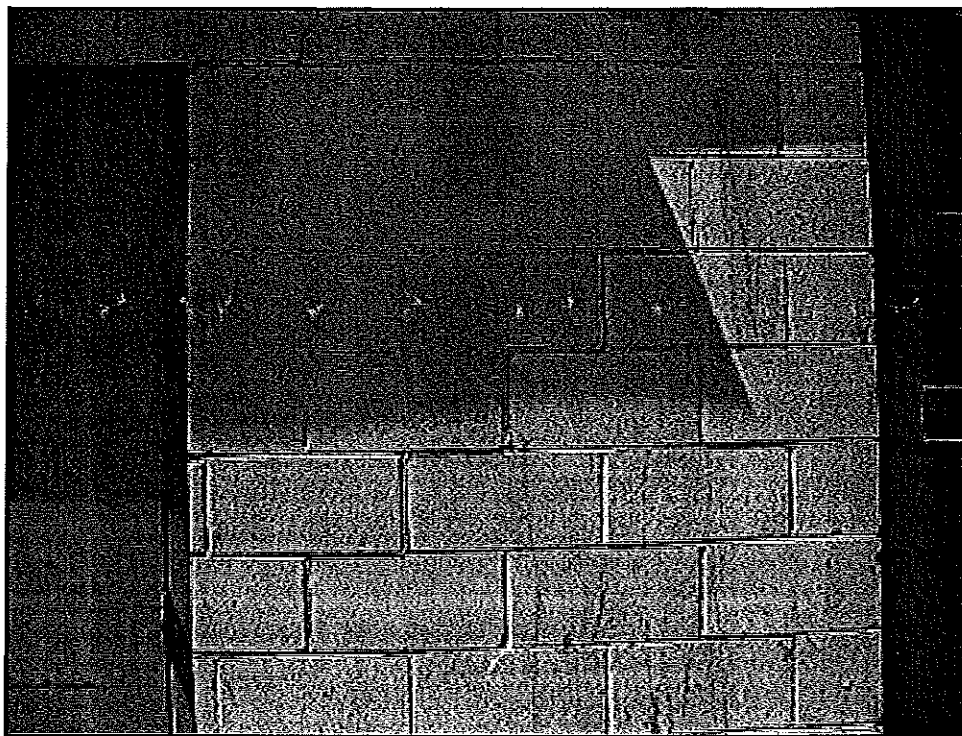
We noted some stepped cracking in the east wall of a small lean-to addition on the east side of the building. This cracking is common in masonry block walls and could be re-pointed.

Step Cracking
Small Lean-To Building

- Try to arrest the leakage from the roof to the east exterior wall
- Re-point the wide crack in the northeast wall corner of Mechanical Room #2
- Re-point the cracking in the masonry wall of the small lean-to building along the east side of the structure.
- If the netting and Low-E fabric covering has to come down for any reason in the future, the top flanges and bolts of the beams over the ice surface should be reviewed.

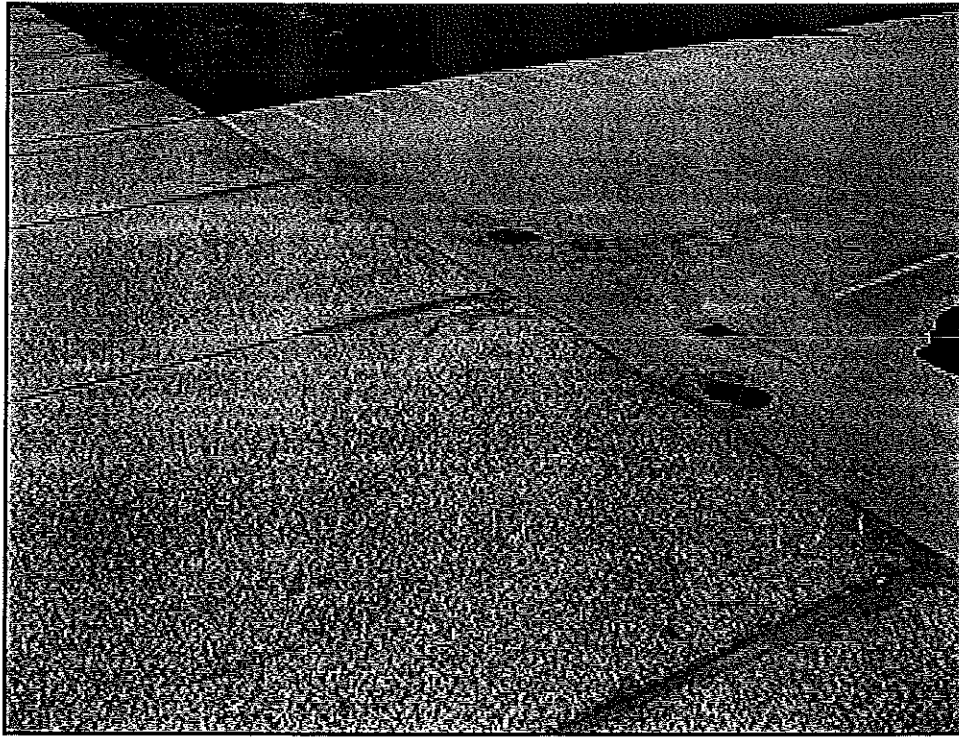
We understand that a modified bitumen roof system was installed over the arena in 2000. We reviewed the roof as part of the overall structure review. We did not observe any punctures or damage to the roofing material. However, as noted above there does not appear to be any system in place for preventing water from penetrating behind the flashing along the east wall. We recommend that you review this with a qualified roofing contractor. It is our opinion that a drip ledge and eavestrough could be installed to reduce the amount of water that is able to leak behind the walls.

East Side of Arena Roof
