Garland Canada Inc.

Infrared Thermographic Roof Inspection

Municipality of South Huron – Recreation Centre
94 Victoria Street East
Exeter, Ontario
N0M 1S1

Inspection Date: **May 9, 2022**
Verification Date: **May 13, 2022**
Representative: **Mr. Nick Fedorow**

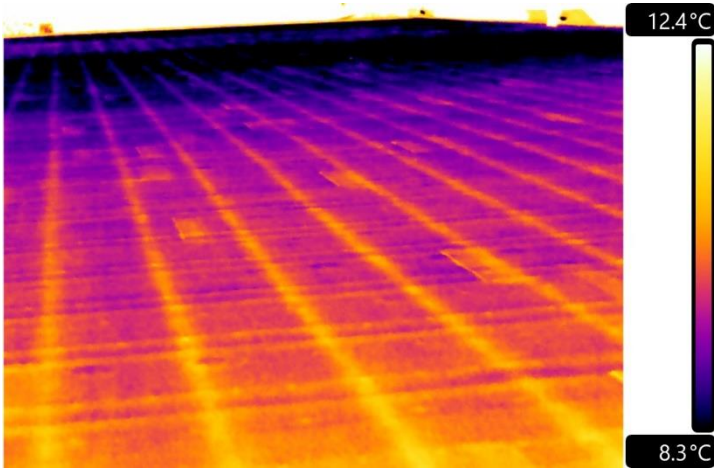
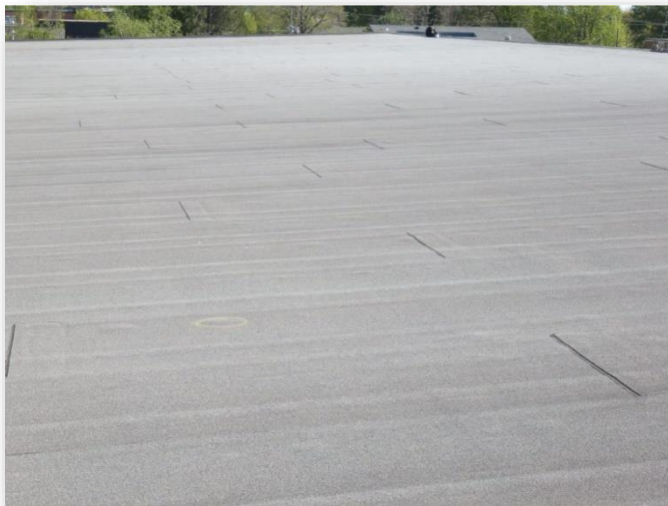
Vantage Point #1

Thermogram looking at typical roof area on Roof Section 1.0.

No suspect anomalies detected on this roof area.

Roof edge shown in background of images.

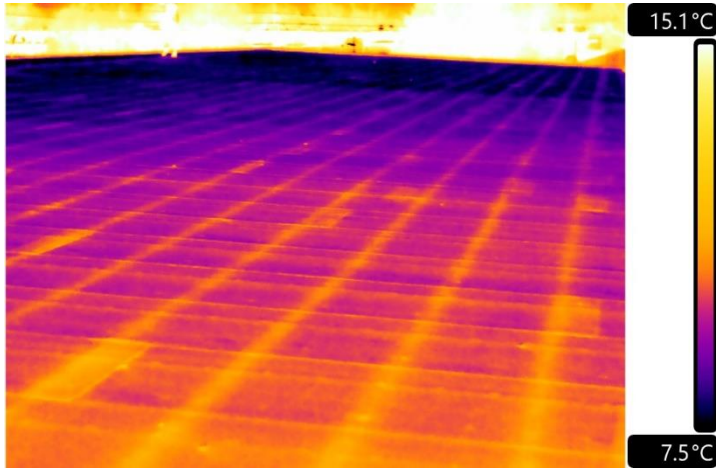
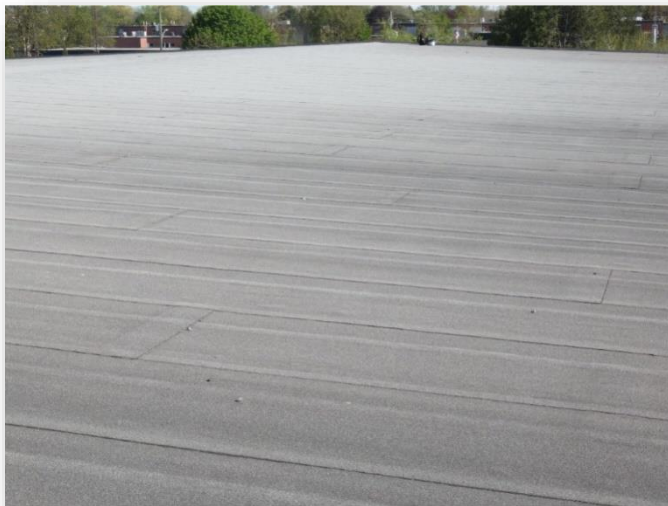
Vantage Point #2

Alternate view Thermogram looking at typical roof area on Roof Section 1.0.

No suspect anomalies detected on this roof area.

Thermal bridging of structural components shown as light coloured lines.

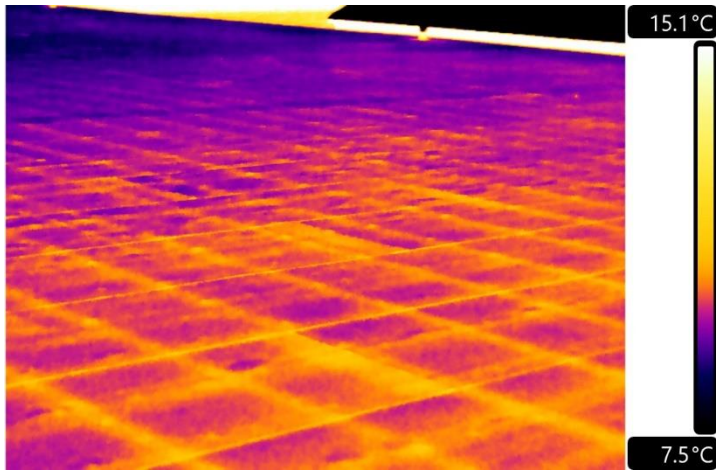
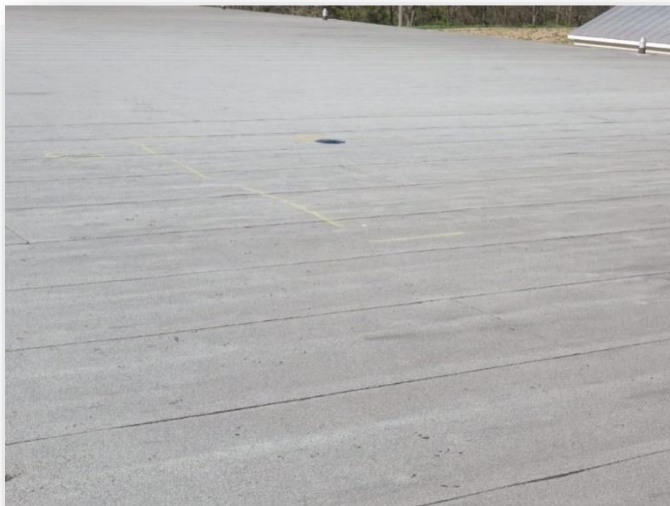
Vantage Point #3

Thermogram looking at typical roof area on Roof Section 1.0.

Verified Core #1 – Dry.

Higher thermal loss noted at this area of roof.

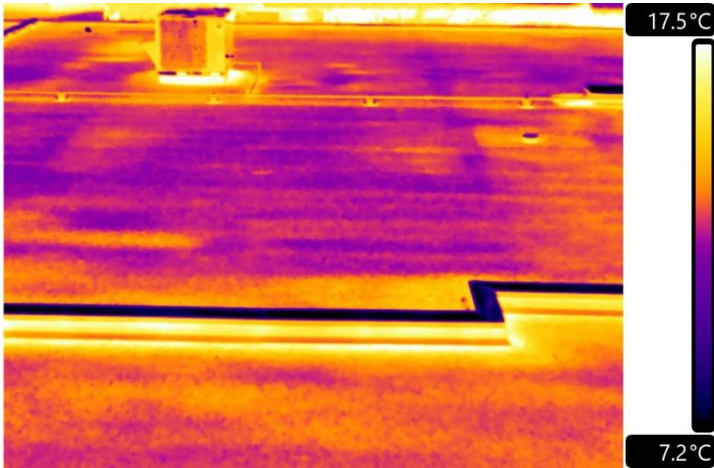
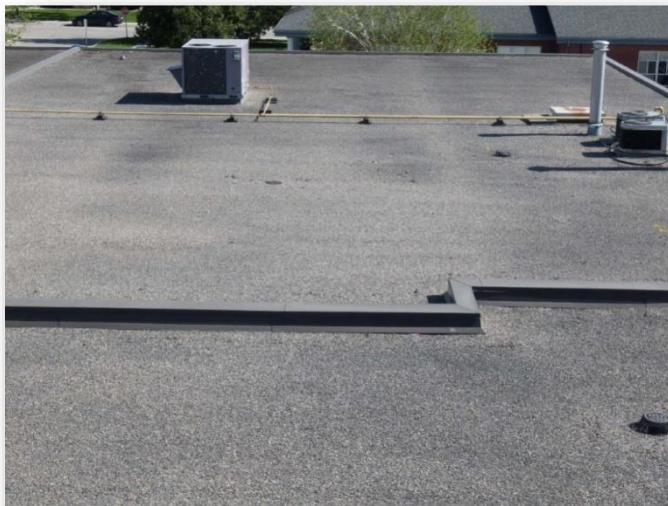
Vantage Point #4

Thermogram looking down from Roof Section 1.0 at typical roof areas on Roof Sections 2.0 & 3.0.

Verified Core #6 – Dry.

Various mechanical units shown in background of images.

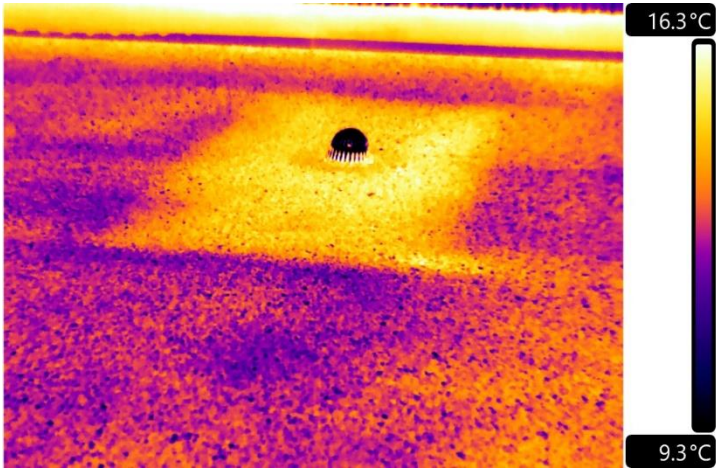
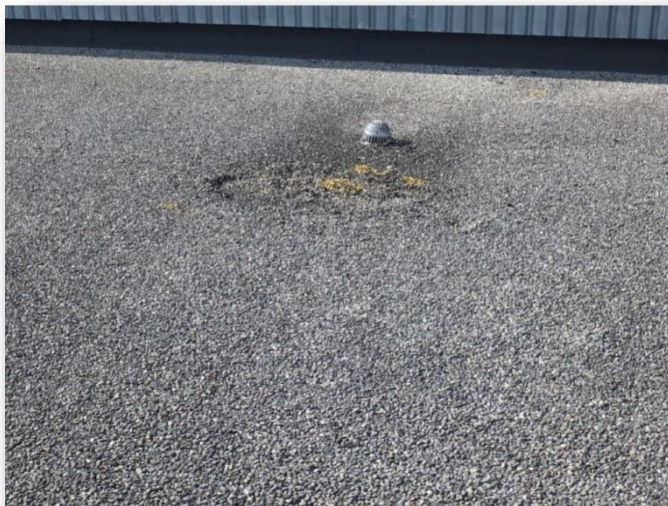
Vantage Point #5

Thermogram looking at suspect anomaly
on Roof Section 2.0.

Verified Probe #2 – Dry.

Drain pan thermal characteristics noted at this location.

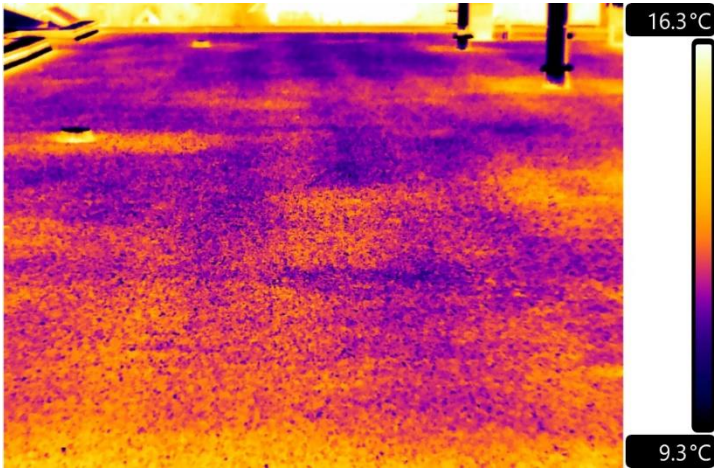
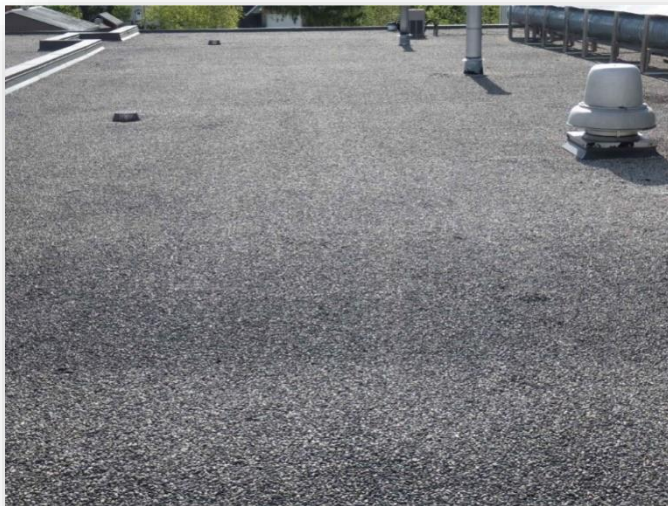
Vantage Point #6

Thermogram looking at typical roof area on Roof Section 2.0.

Roof drain & roof edge shown in background of images.

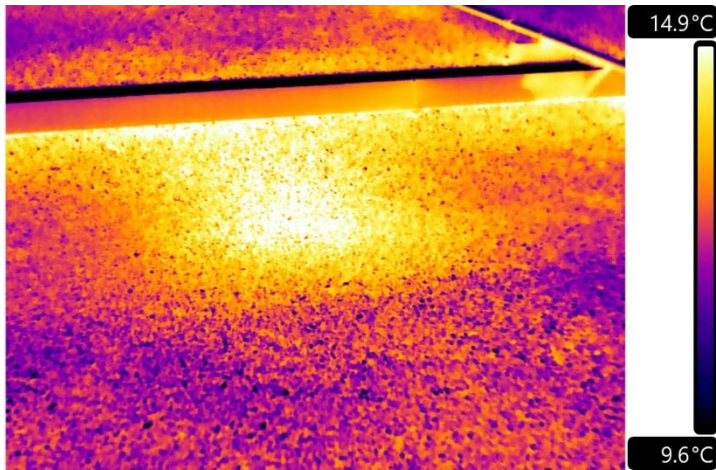
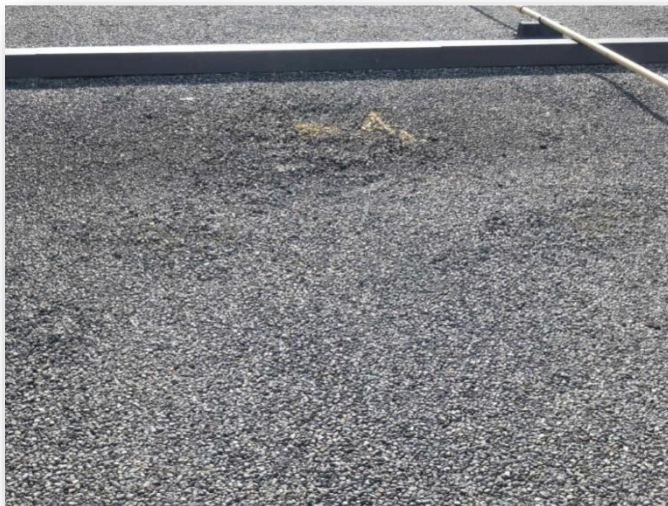
Vantage Point #7

Thermogram looking at suspect anomaly on Roof Section 4.0.

Verified Probe #4 – Dry.

Higher thermal retention caused by excess ballast (gravel) noted at this area.

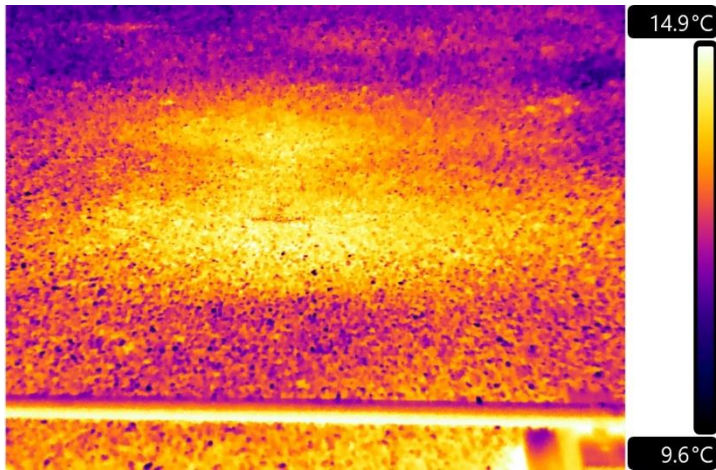
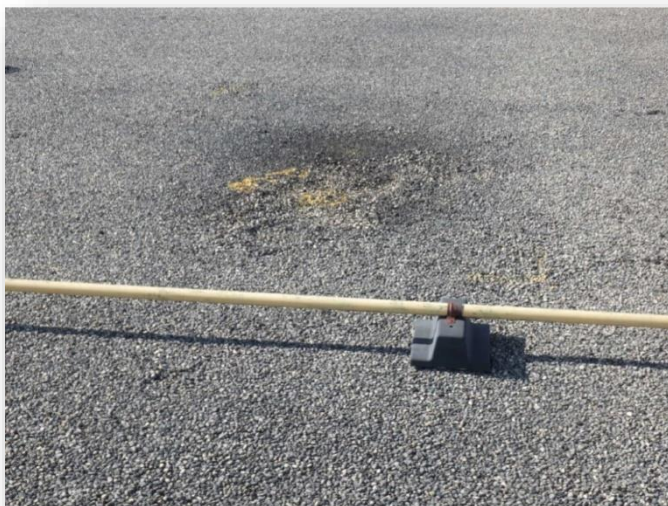
Vantage Point #8

Thermogram looking at suspect anomaly on Roof Section 4.0.

Verified Probe #3 – Dry.

Gas line shown at foreground of images.

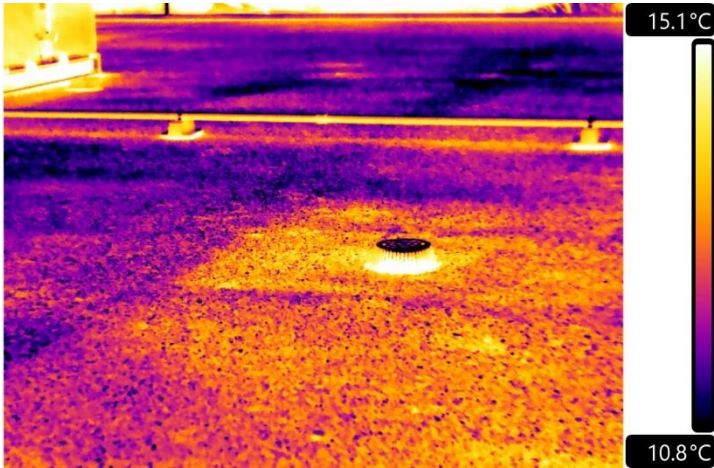
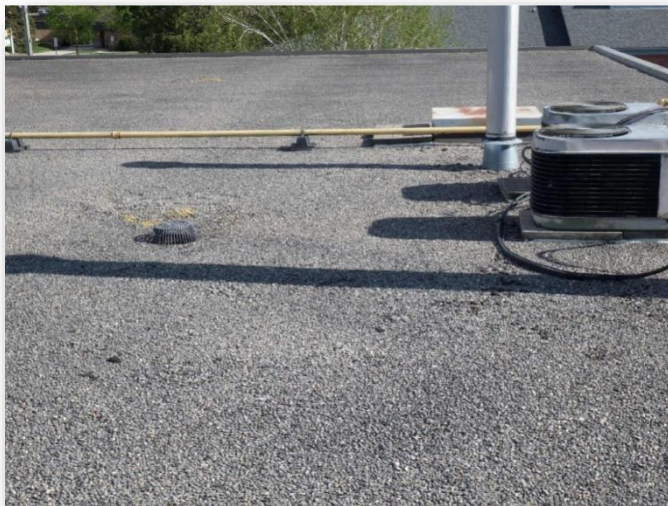
Vantage Point #9

Thermogram looking at suspect anomaly on Roof Section 3.0.

Verified Probe #5 – Dry.

Higher thermal retention caused by excess ballast (gravel) and thicker top pour noted at this area.

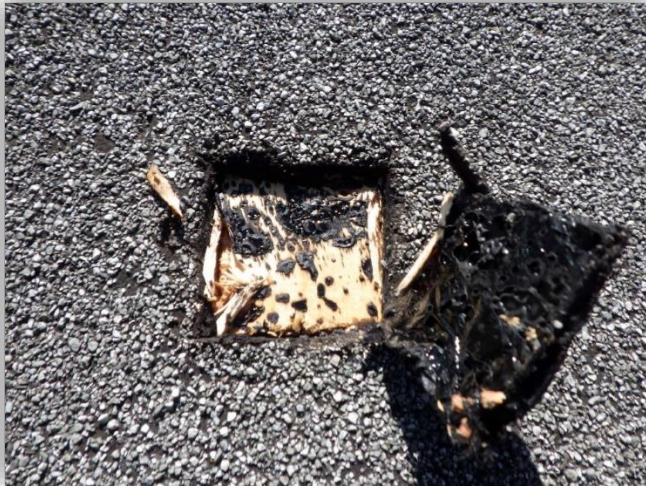
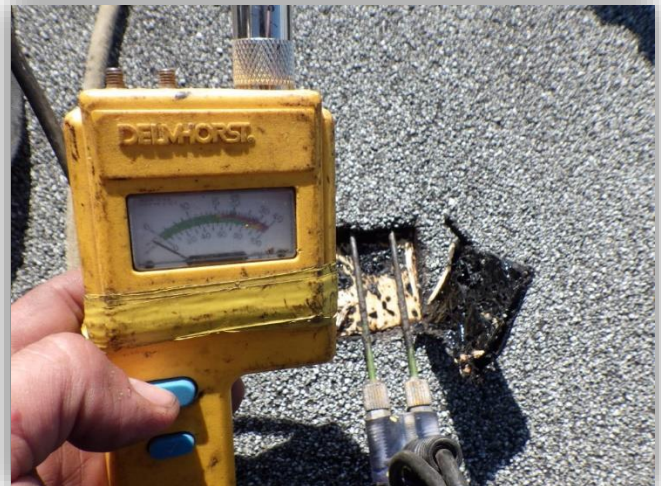
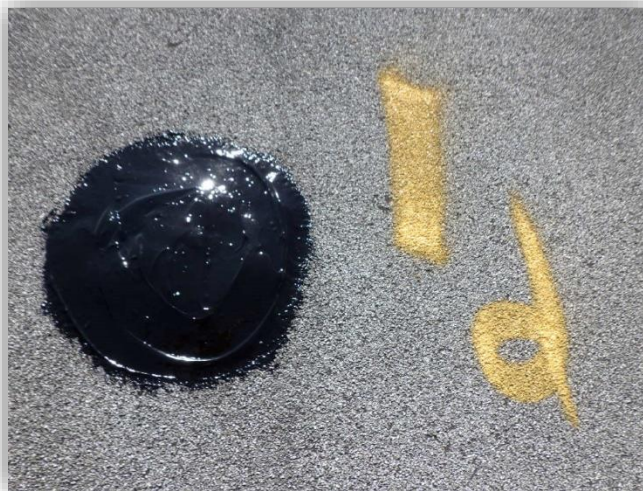
Core Cut #1

Layer Type	Description	Condition	Thickness
Surfacing	Granular	-	-
Membrane	Modified Bitumen	Fair	-
Felts	2 Ply	Dry	-
Insulation	None	-	-
Vapor Barrier	None	-	-
Deck	Wood	Good	-

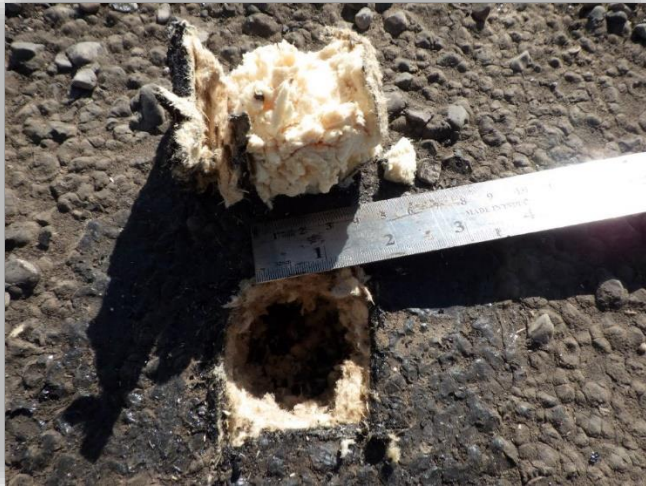
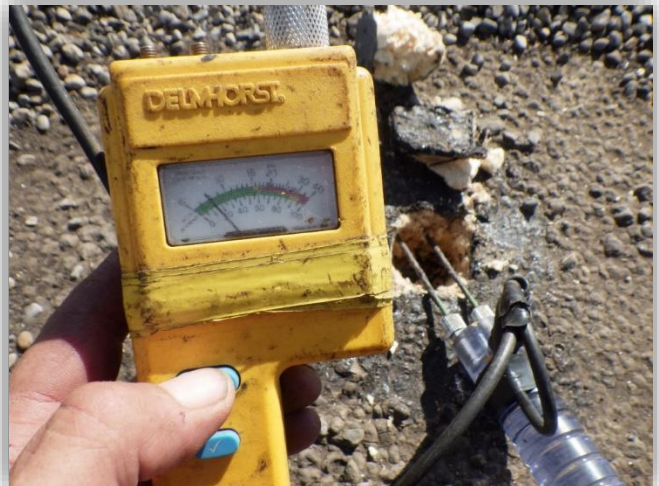
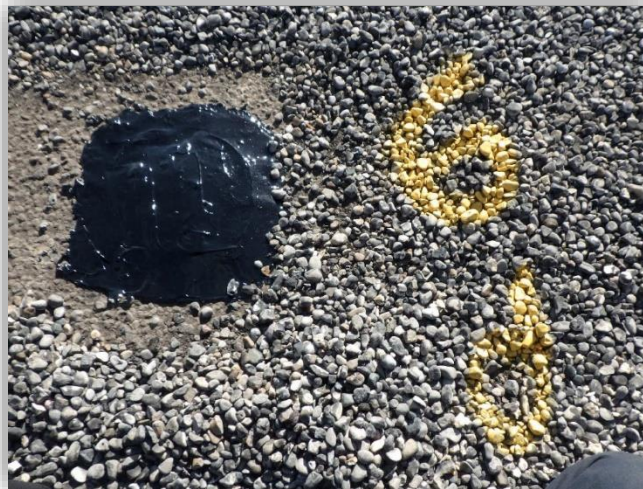
Core Cut #6

Layer Type	Description	Condition	Thickness
Surfacing	3/8" Gravel	-	-
Membrane	Built Up Roof - Asphalt & Gravel	Fair	-
Felts	4 Ply	Dry	-
Insulation	Fiberboard	Dry	1/2"
Insulation	Polyisocyanurate	Dry	2"
Vapor Barrier	Kraft Paper	-	-
Deck	Metal	Good	-

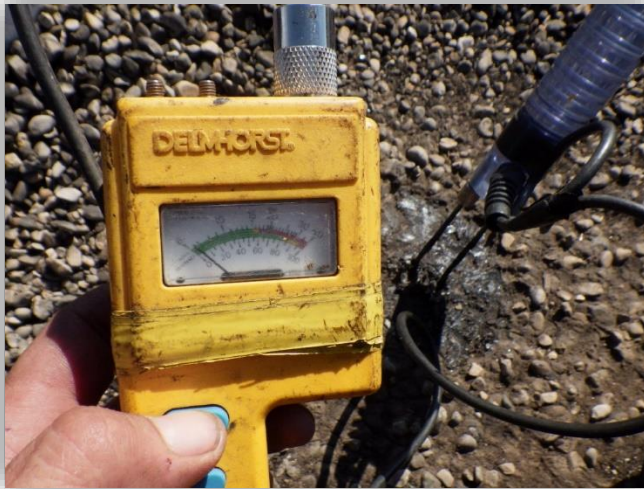
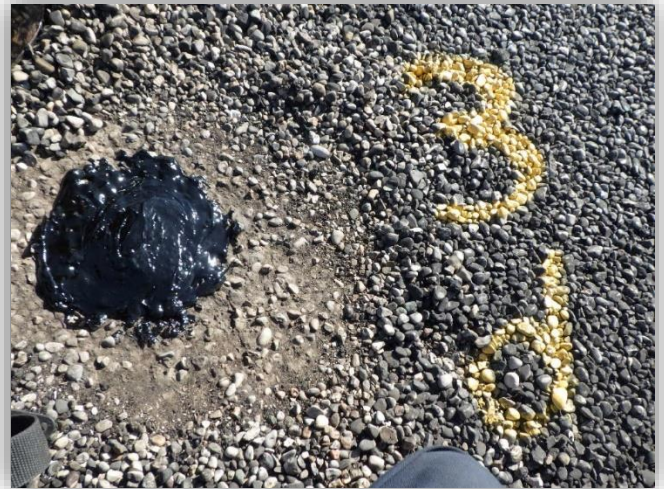
Probe #3 Roof Section 4.0

Moisture Probe Reading: Dry Insulation

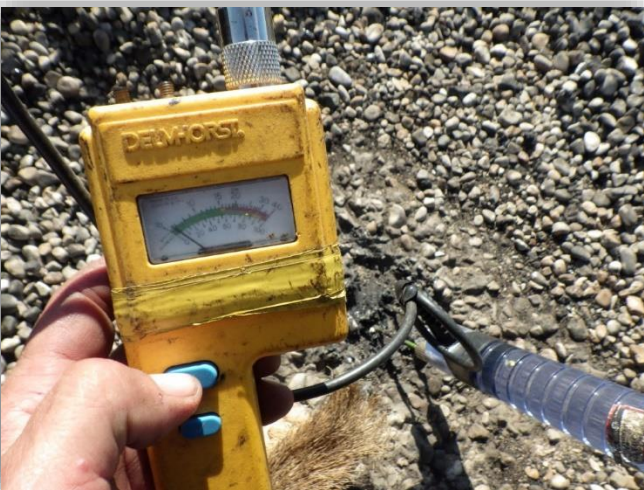
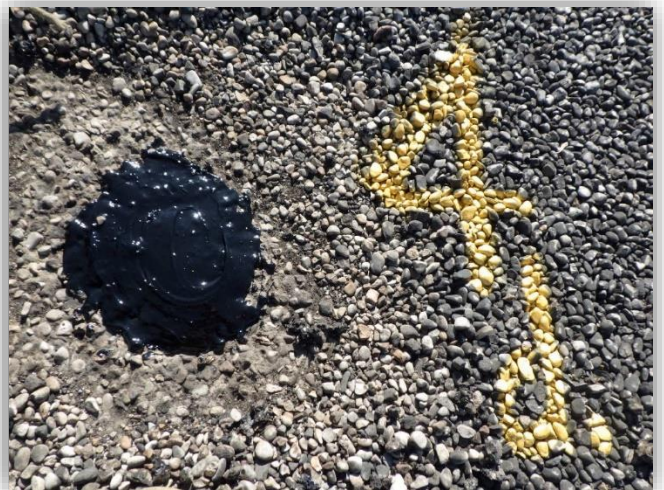
Probe #4 Roof Section 4.0

Moisture Probe Reading: Dry Insulation

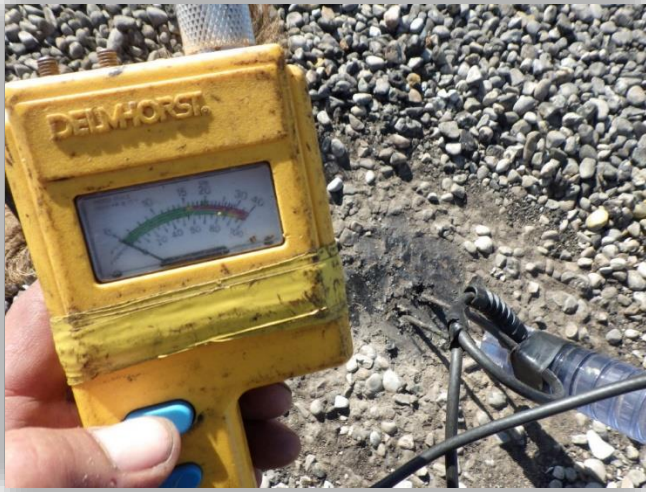
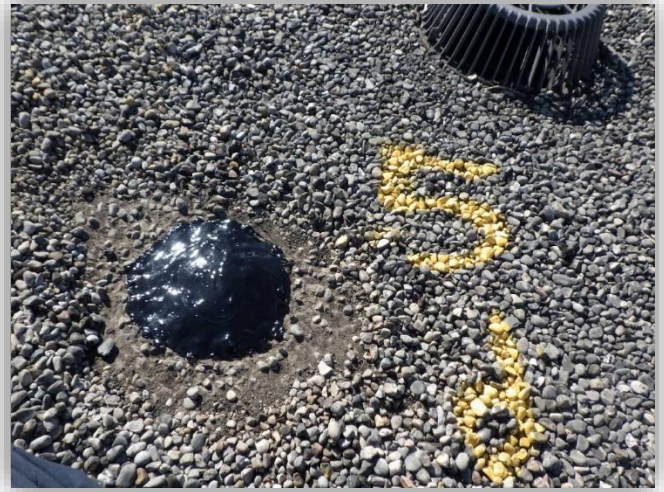
Probe #5 Roof Section 3.0

Moisture Probe Reading: Dry Insulation
