**B. M. ROSS AND ASSOCIATES LIMITED**  
**Engineers and Planners**  
62 North Street, Goderich, ON N7A 2T4  
p. (519) 524-2641 [www.bmross.net](http://www.bmross.net)

March 18, 2021

**RE: Structural Review of the South Huron Recreation Centre**

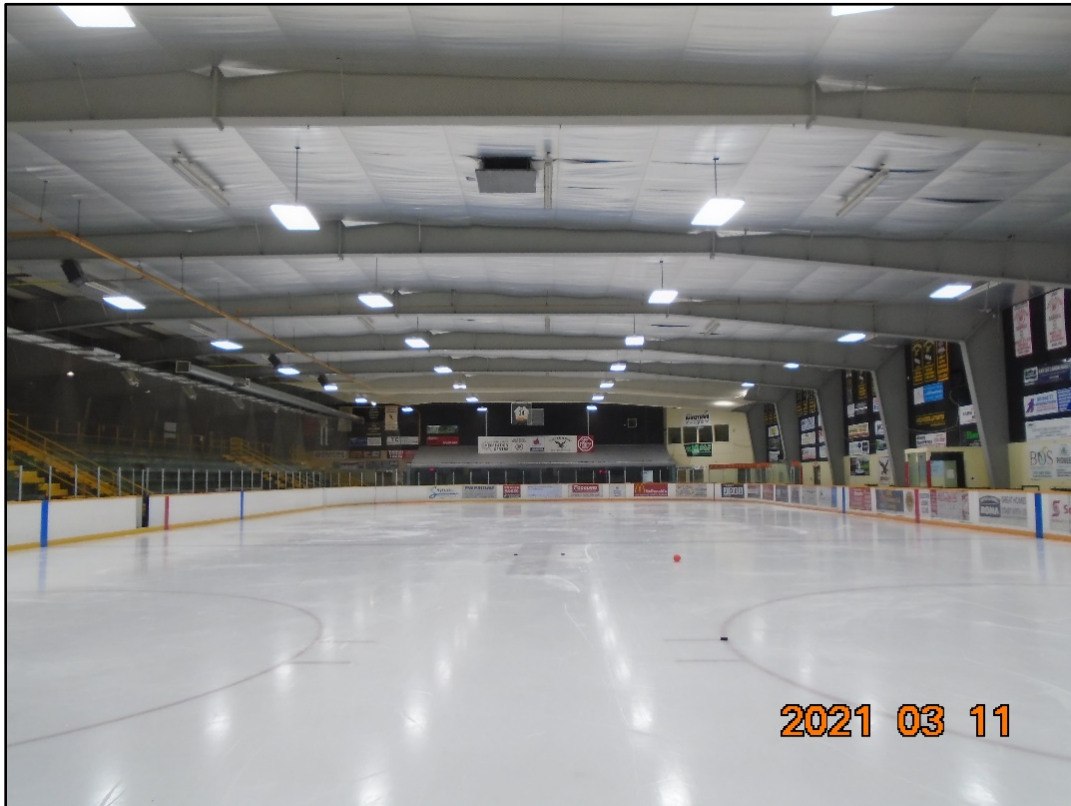
**Arena Facing South**

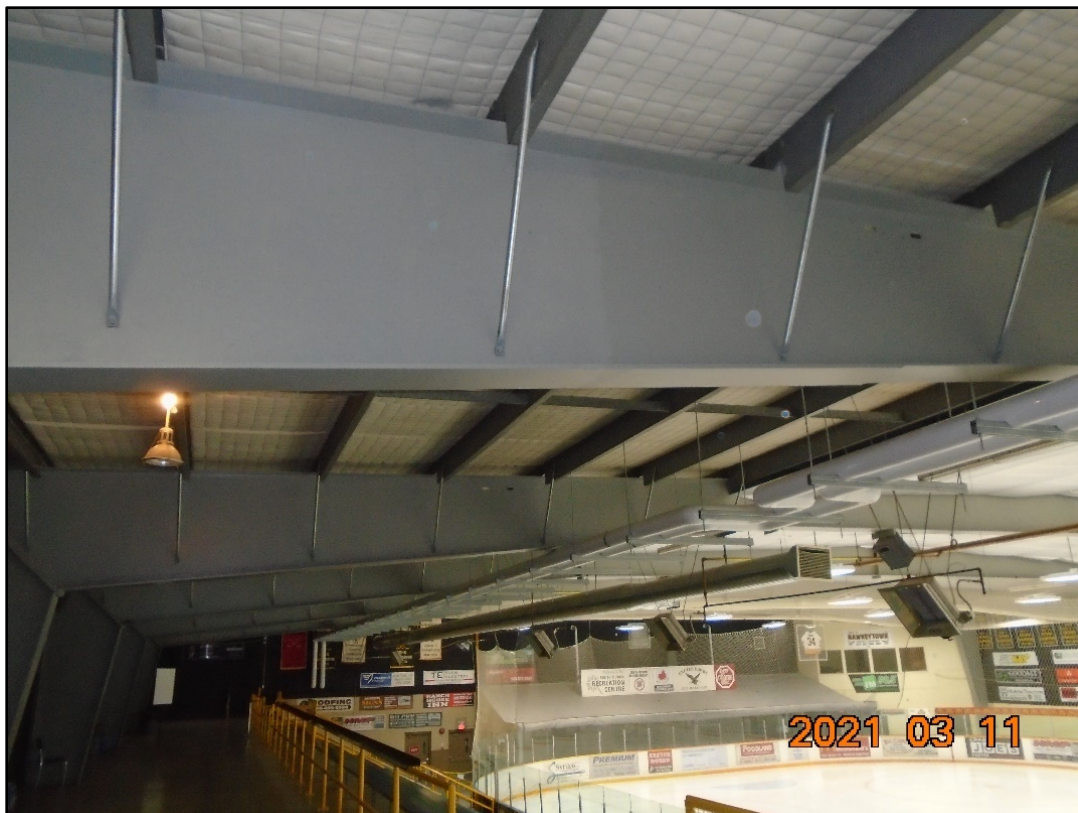
We understand that the steel structure was painted in 2003. There are some minor paint failures and localized rusting on the top flange and at many of the bolts that connect the top flanges together. However, this deterioration is superficial and is not significant to the structure.

**Typical Coating Condition**

- Re-paint the structural steel framing over the ice surface.
- Paint or replace bolts in the top flange connections.
- Replace/repair the roofing membrane over the ice surface.
- Replace/repair the roof over the hall/foyer.

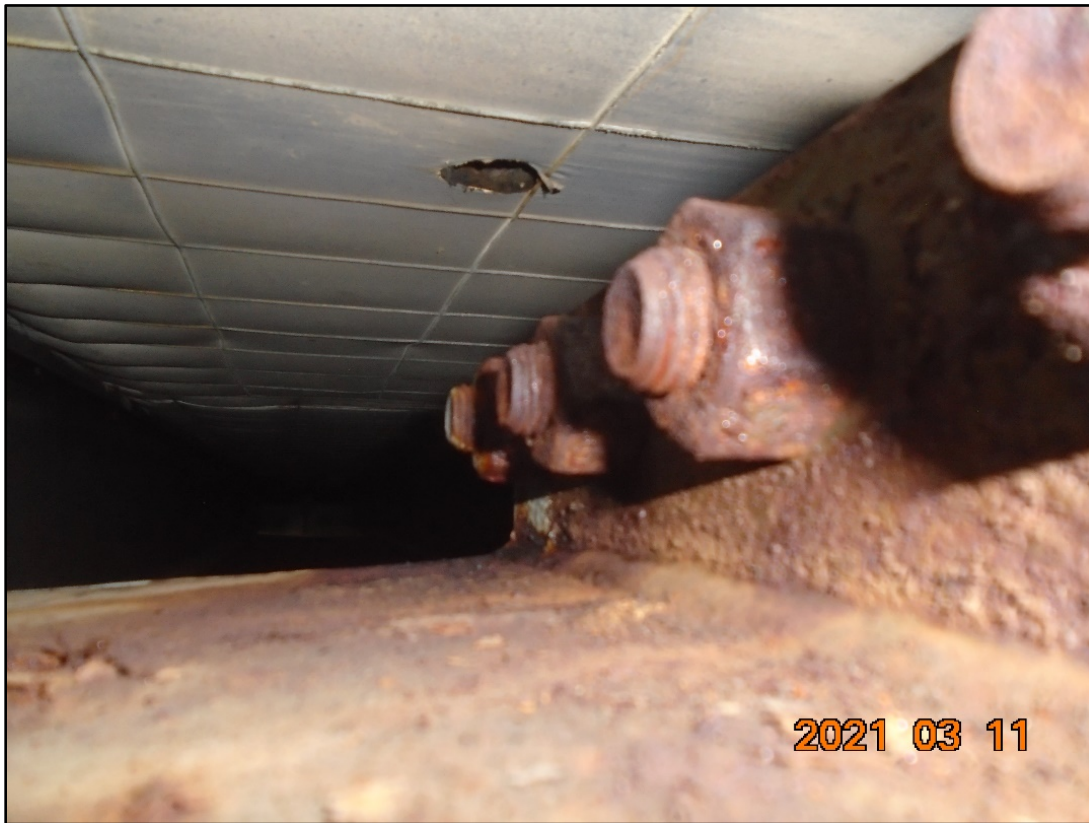
**Bolts at Top of Beam Over Ice Surface**

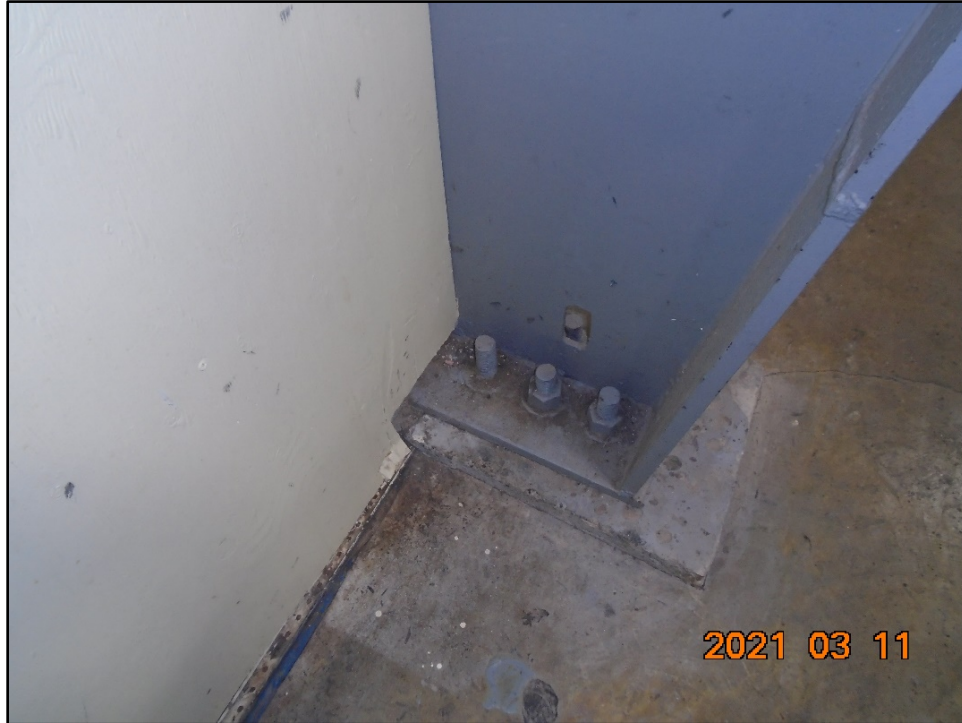
We noted one nut missing from the base plate of the seventh column from the north end on the west side of the ice surface, and in Dressing Room 3. They should be replaced. We

**Missing Nut at Base of 7<sup>th</sup> Column from North End Wall – West Side of Ice Surface**

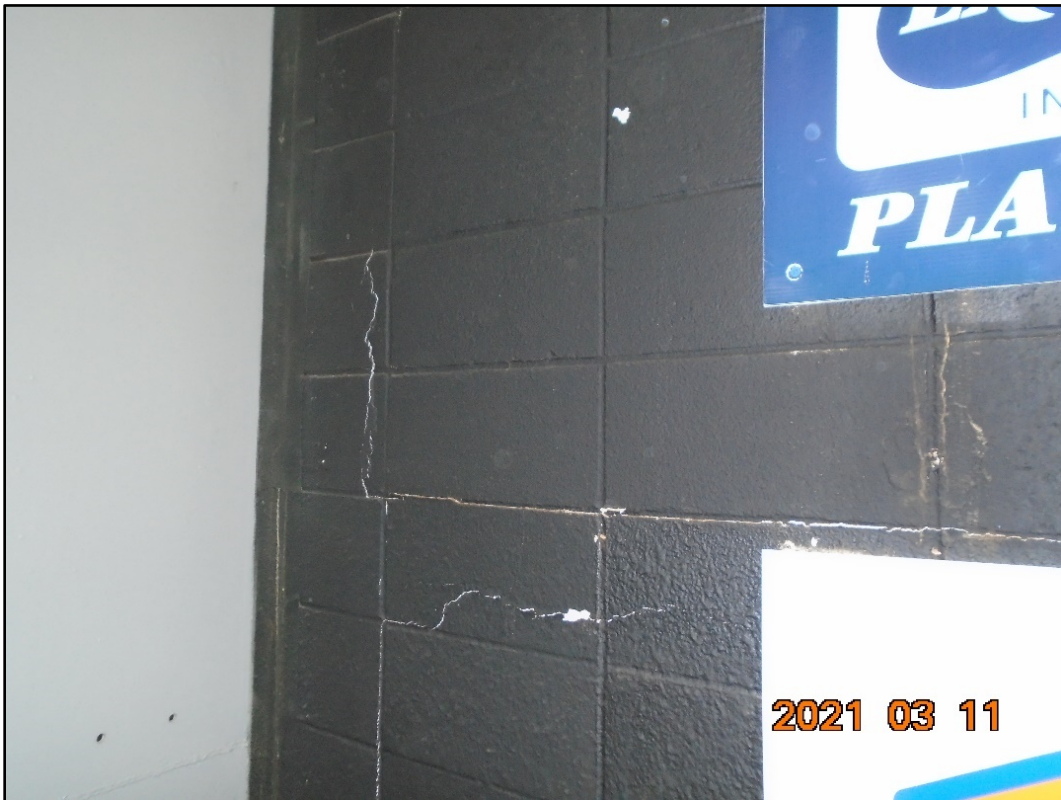
We noticed cracking in the concrete blocks of the west wall of the ice surface adjacent to the centreline of the rink. The cracking is located about two-thirds of the way up the wall and appears to be relatively recent. In this area, we also observed a horizontal shear ledge (8mm). We can't say for certain if the shear ledge formed recently because the area is partially covered by donor signboards and could have been missed during past inspections. The shear ledge spans most of the distance between the columns. We are not certain of the source of the shear ledge or the cracking. We recommend closely reviewing the roofing system / flashing adjacent to this area and sealing any gaps to prevent moisture ingress. We recommend removing and replacing the cracked blocks and mechanically reinforcing the shear ledge within the 1-to-5-year period. If the steel siding must come off the building for any reason, it would be ideal to repair the wall prior to the siding replacement. This may allow for a better repair and may allow investigation as to why the cracking has occurred.

**Cracking and Shear Ledge in West Masonry Wall of Ice Surface**

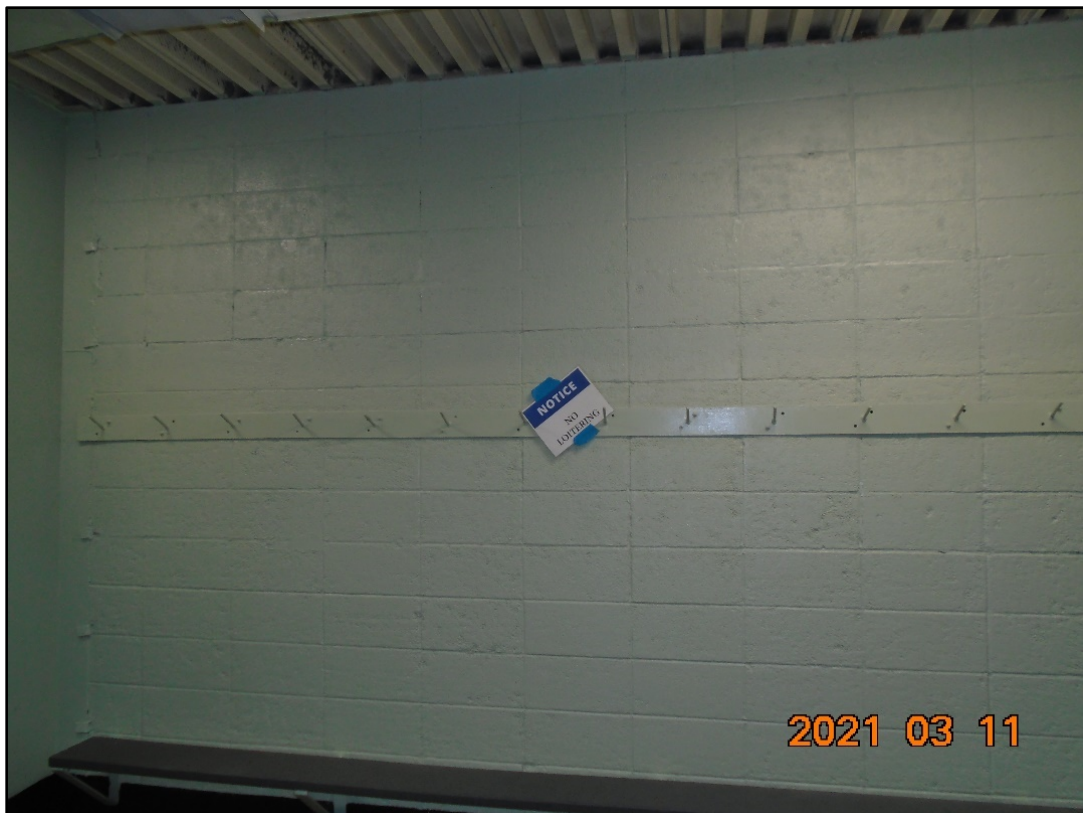
We reviewed the space under the viewing stands, the mechanical rooms, dressing rooms and washrooms and found them to be in fair to good condition. As noted previously there are signs that water has leached through the east wall of Dressing Rooms 3 and 4, and Mechanical Room 2. However, there were no signs that the problem exists currently. The paint appeared to be well adhered to the wall and the area adjacent to the efflorescence stains in the Mechanical Room was dry. It is noted that staff have not observed any moisture penetration in these areas in recent years.

**East Masonry Wall of Dressing Room 4**

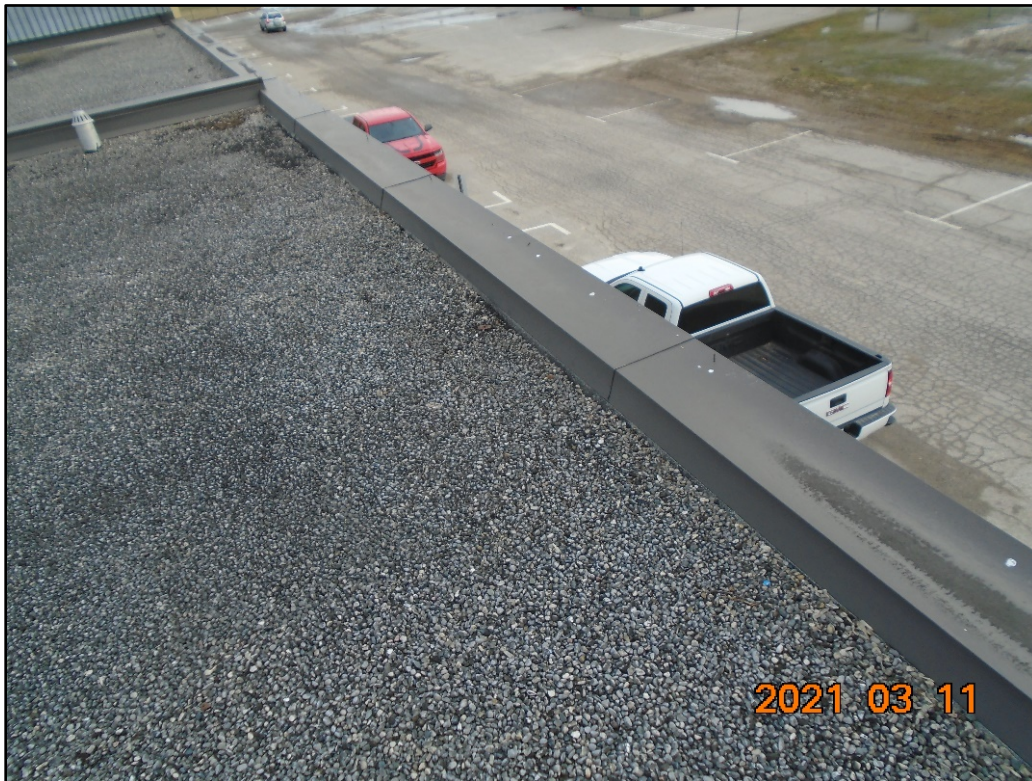
**Loose Flashing Screws – East Wall of Hall**

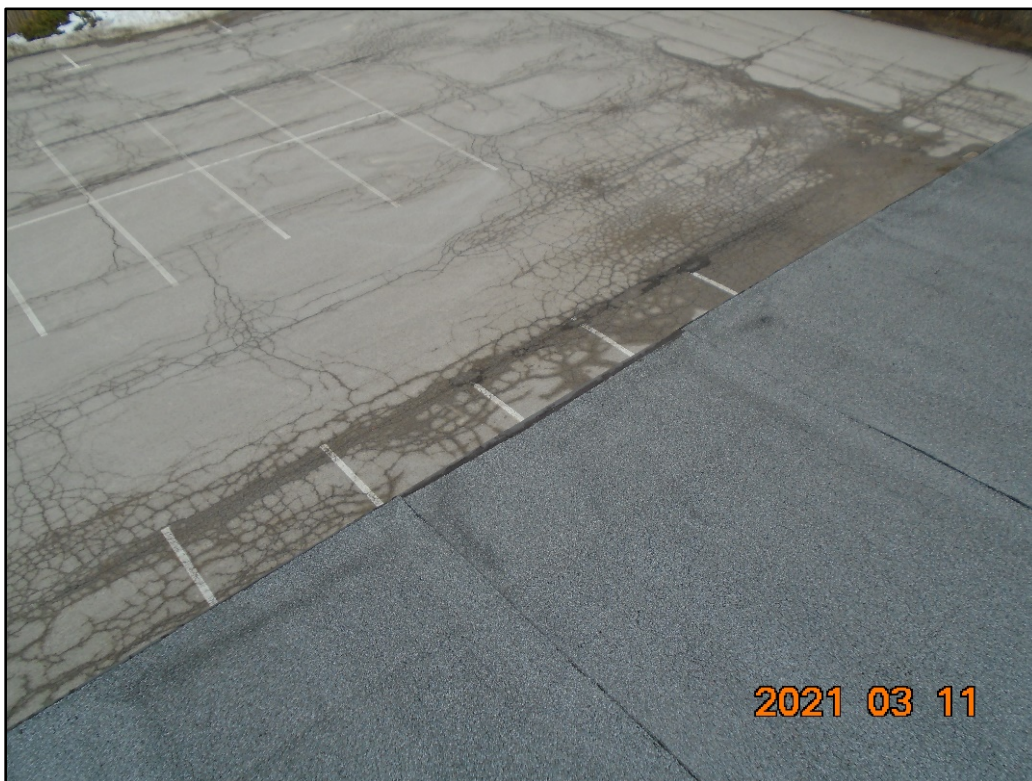
It is recommended that any signs of moisture penetration be noted, and efforts be taken to find the source of the problem. It is recommended that the roof flashing be reviewed regularly and secured and repaired as required. Since there is no flashing at the edges of the roofing over the ice surface, it is recommended that the perimeter be sealed where gaps are present between the roofing and the flashing. Concrete block can potentially be weakened by the water leaching.

**Gap Between Roofing and Flashing over Ice Surface – East Wall**

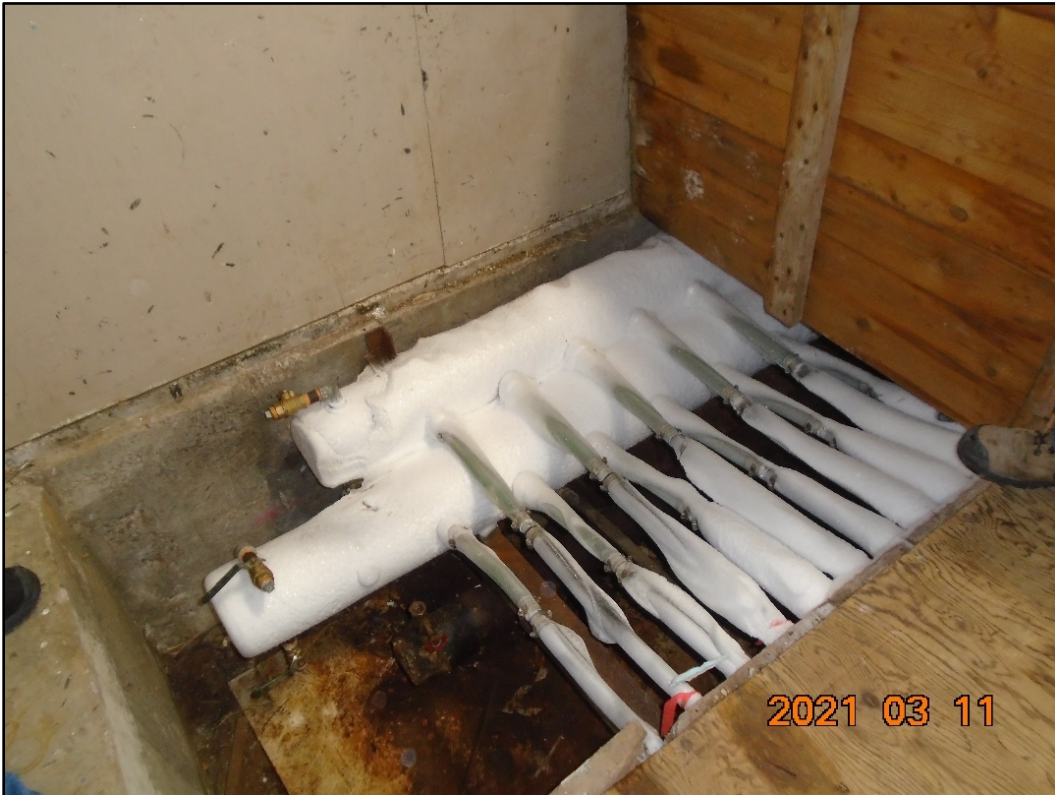
At the time of the review, the exposed portion of the underground header and pipes for the cooling system below the floor slab of the ice rink were covered in frost. We agree with staff that it would be prudent to review supports for corrosion when the frost has melted. It may be possible to add additional supports between the existing if significant deterioration is observed.

**Header and Pipes for Ice Surface Cooling**
