March 16, 2022

LON-22007315-A0

Re: **Roof Condition Assessment  
South Huron Recreation Center  
Exeter, ON**

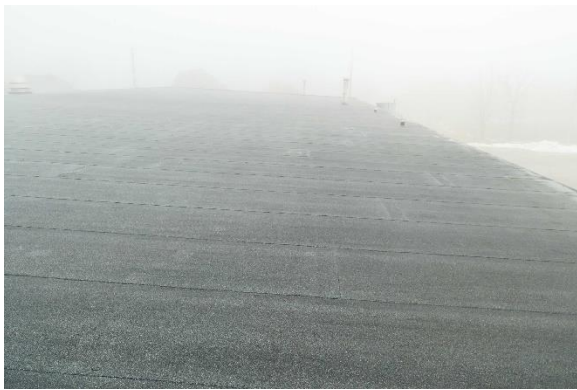
- 4.1.1 EXP observed the modified bitumen membrane to be in fair-to-poor condition (Reference Photo Exhibit Nos. 1-4).
- 4.1.2 Throughout the roof area, EXP observed evidence of hail damage. Hail strikes ranged from 1/4" to greater than 1" in size/diameter. The impact damage to the membrane has exposed the bitumen and roofing felts to UV light, which contributes to premature roof membrane failure (Reference Photo Exhibit Nos. 5-9).

**Photo Exhibit No. 1**  
**Overall of arena Roof. Fair-to-poor condition.**

- 5.1.1 EXP recommends performing a roof restoration on this area in the next 0-2 years.
- 5.1.2 Based on the observed condition of the roof, as well as the composition of the roof, EXP believes this roof area would be an excellent candidate for a “re-cap/re-cover”. This would involve overlaying a brand-new cap sheet (modified bitumen membrane) on top of the existing roof. Prior to performing this restoration work, various items would need to be carried out (as a requirement of the new cap-sheet membrane manufacturer, to meet their workmanship/material warranty);

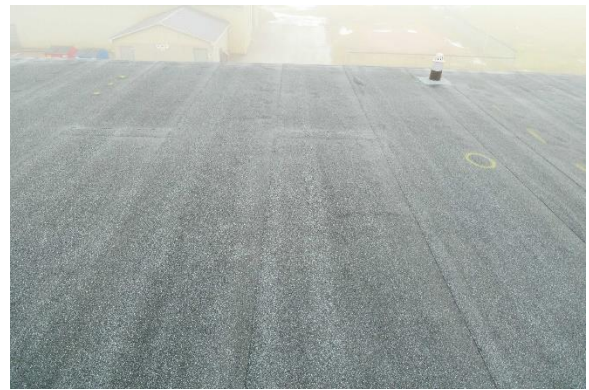
**Photo Exhibit No. 4**  
**Overall of arena Roof. Fair-to-poor condition.**

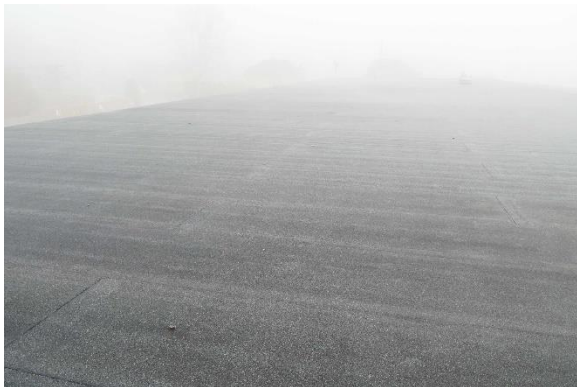
**Photo Exhibit No. 2**  
**Overall of arena Roof. Fair-to-poor condition.**

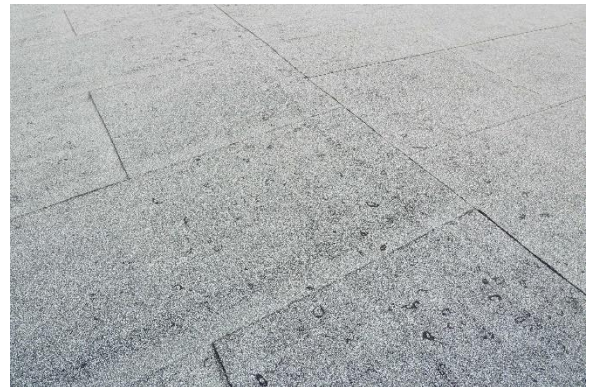
**Photo Exhibit No. 5**  
**Large amount of hail damage present on roof.**

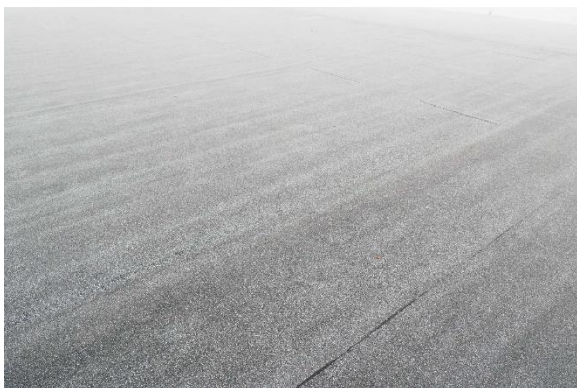
**Photo Exhibit No. 3**  
**Overall of arena Roof. Fair-to-poor condition.**

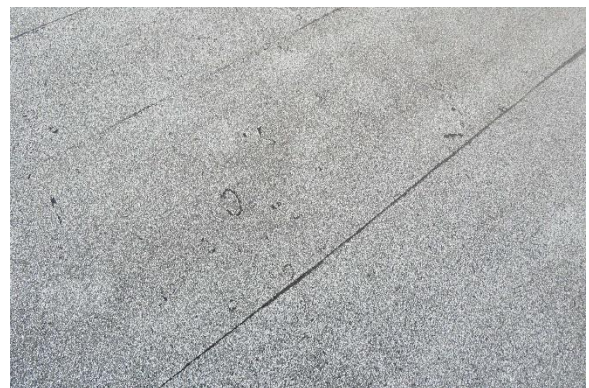
**Photo Exhibit No. 6**  
**Large hail strikes on the roof.**

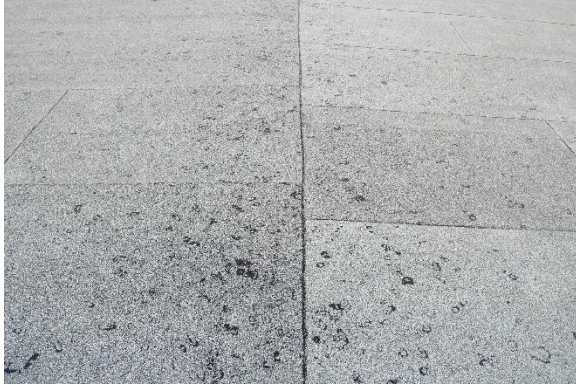
**Photo Exhibit No. 7**  
**Large hail strikes on the roof.**

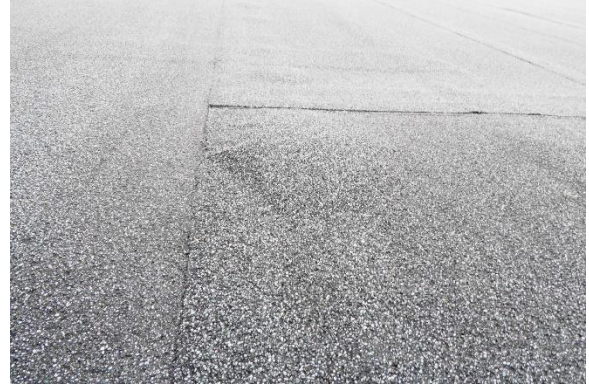
- 4.1.3 At select locations, EXP observed blisters in the roof membrane. Blisters within the roof system will accelerate deterioration of the roofing system and could lead to water infiltration into the building envelope (Reference Photo Exhibit Nos. 10-12).

**Photo Exhibit No. 10**  
**Large blister beneath cap sheet.**

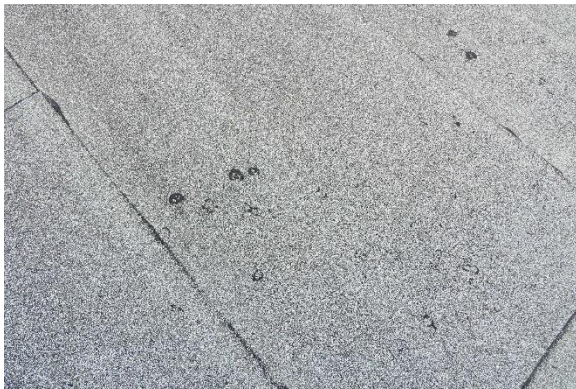
**Photo Exhibit No. 8**  
**Large hail strikes on the roof.**

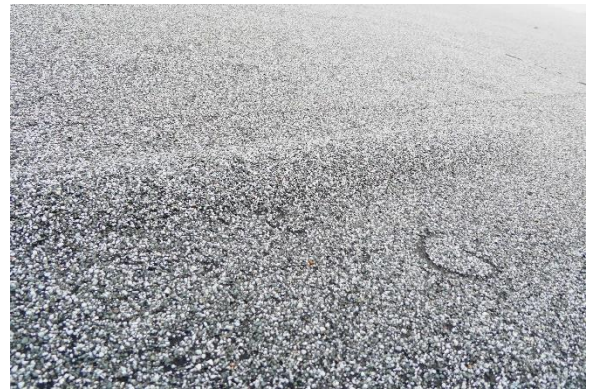
**Photo Exhibit No. 11**  
**Large blister beneath cap sheet.**

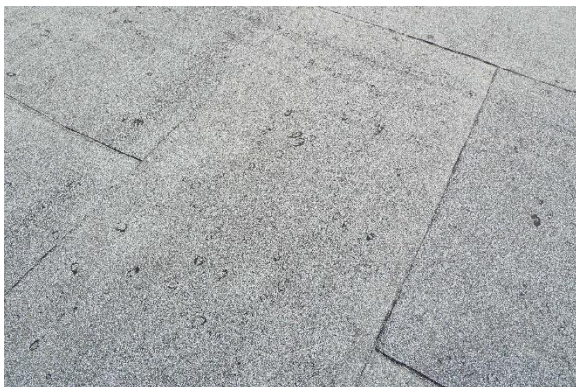
**Photo Exhibit No. 9**  
**Large hail strikes on the roof.**

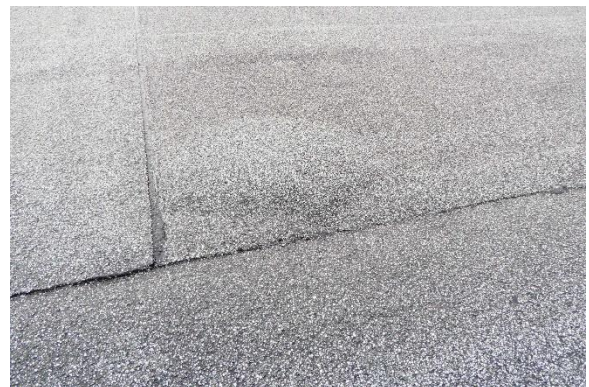
**Photo Exhibit No. 12**  
**Large blister beneath cap sheet.**

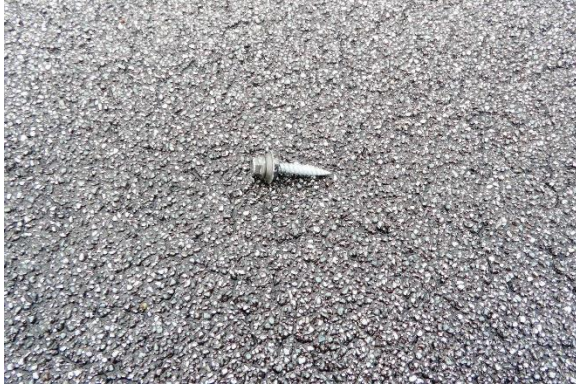
- 4.1.4 Varying levels of debris were observed on the roof. Fasteners and stones were observed scattered across the roof area. If not addressed, these can cause damage to the roof membrane (Reference Photo Exhibit No. 13).

**Photo Exhibit No. 13**  
Fastener/debris on roof area.

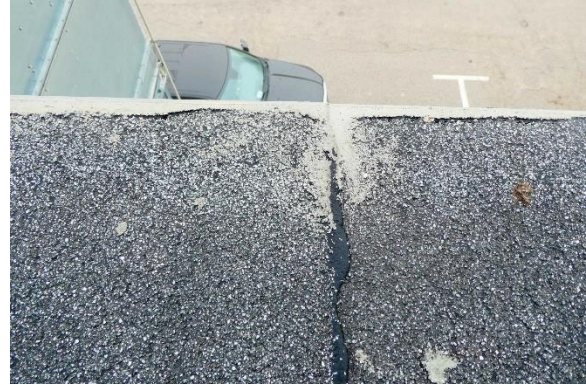
- 4.1.5 At the east edge of the roof, EXP observed ponding water adjacent to the roof edge (Reference Photo Exhibit Nos. 14 and 15).
- 4.1.6 Sealant and/or unknown repair methods at the east edge of the roof at various seams and joints in the roof membrane were observed to have failed (Reference Photo Exhibit Nos. 16 and 17).

**Photo Exhibit No. 16**  
Failure of sealant/repair.

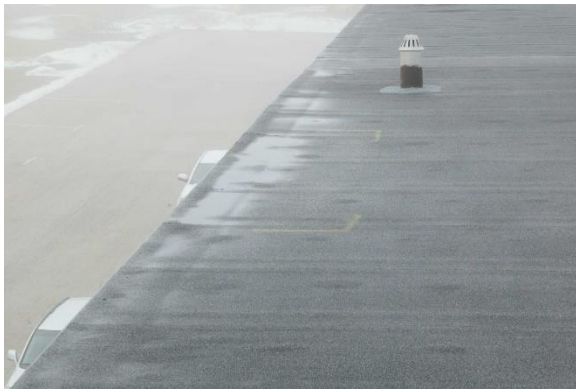
**Photo Exhibit No. 14**  
Ponding water at roof edge.

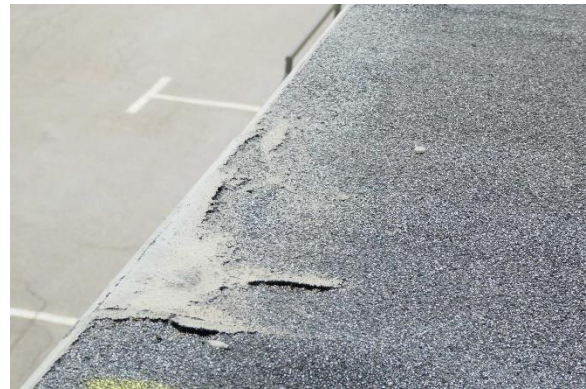
**Photo Exhibit No. 17**  
Failure of sealant/repair.

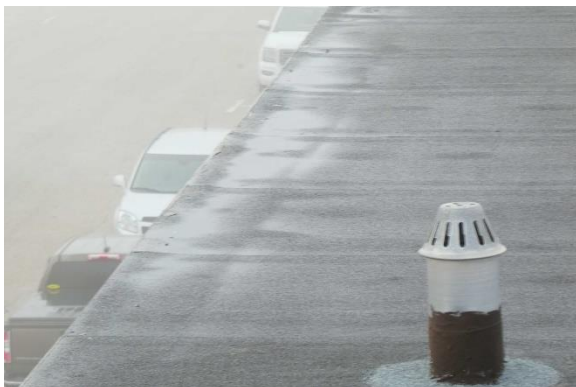
**Photo Exhibit No. 15**  
Ponding water at roof edge.

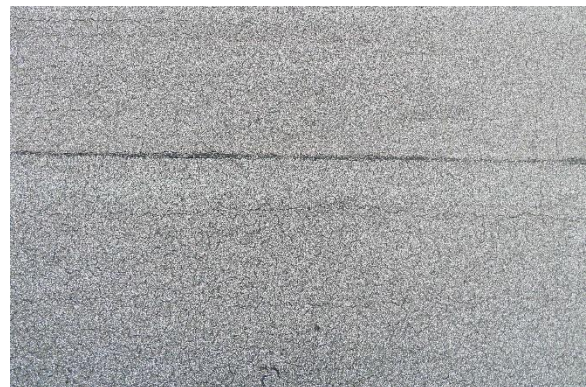
- 4.1.7 “Alligatoring” and damaged cap sheet were observed throughout the roof area. This type of failure indicates that the roof membrane is at/nearing the end of its useful service life (Reference Photo Exhibit Nos. 18-20).

**Photo Exhibit No. 18**  
Alligatoring/damaged cap sheet membrane.

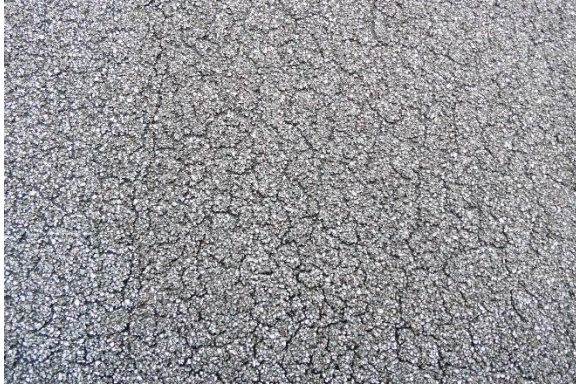
**Photo Exhibit No. 19**  
**Alligatoring/damaged cap sheet membrane.**

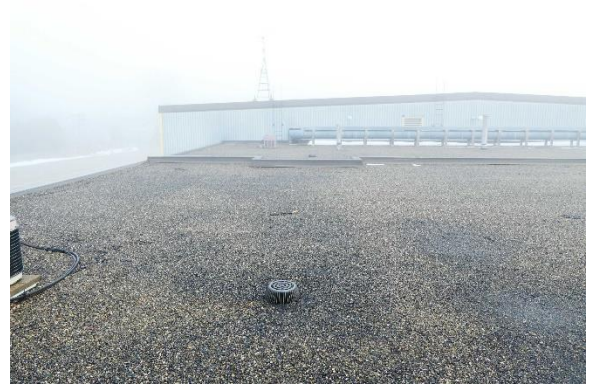
- 4.2.1 EXP observed the BUR at this area to be in fair-to-poor condition (Reference Photo Exhibit Nos. 21-24).
- 4.2.2 Large areas of ponding water were observed throughout the roof area. If left unattended these areas can cause accelerated deterioration of the roof (Reference Photo Exhibit Nos. 25-27).
- 4.2.3 EXP observed “blueberries” throughout the roof area. These deficiencies occur when water is trapped within the system and expands. This can lead to premature roof failure and water infiltration into the building (Reference Photo Exhibit Nos. 28-30).
- 4.2.4 Deteriorated sealant was observed at the metal cap flashing joints at most locations at the roof perimeter and expansion joint locations on this roof area. Additionally, the metal was observed to be near level/flat which prevents water from shedding off in a timely manner (Reference Photo Exhibit Nos. 31 and 32).

**Photo Exhibit No. 22**  
**Overall of recreation center roof.**

- 5.2.2 Based on the observed condition, as well as the composition of the roof, EXP recommends carrying out a full replacement of the roof, down to the roof deck.

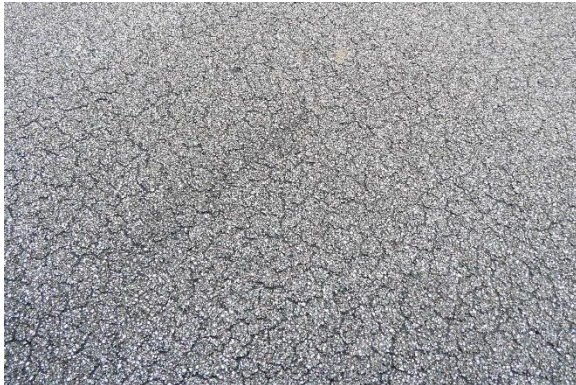
**Photo Exhibit No. 20**  
**Alligatoring/damaged cap sheet membrane.**

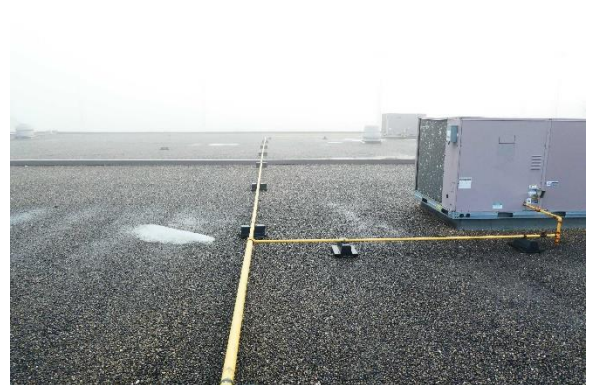
**Photo Exhibit No. 23**  
**Overall of recreation center roof.**

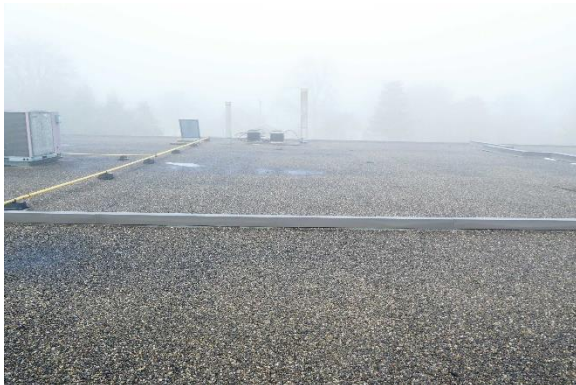
**Photo Exhibit No. 21**  
**Overall of recreation center roof.**

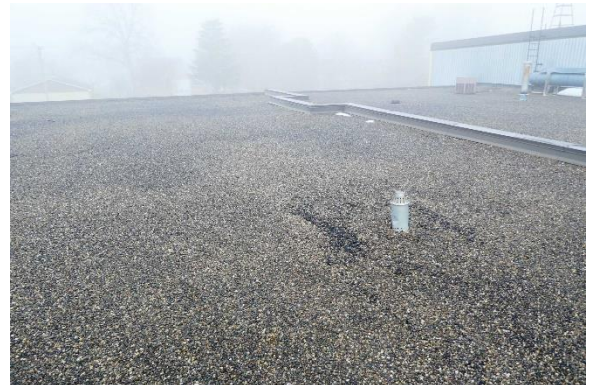
**Photo Exhibit No. 24**  
**Overall of recreation center roof.**

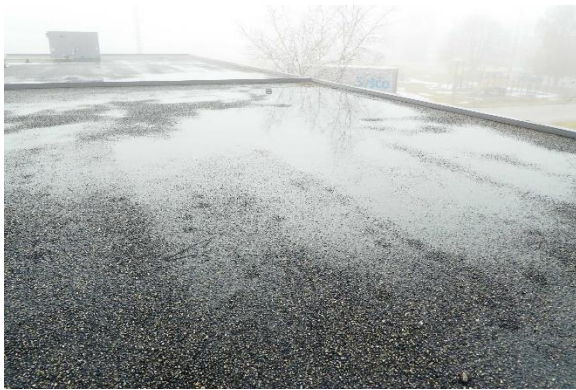
**Photo Exhibit No. 25**  
**Large area of ponding water.**

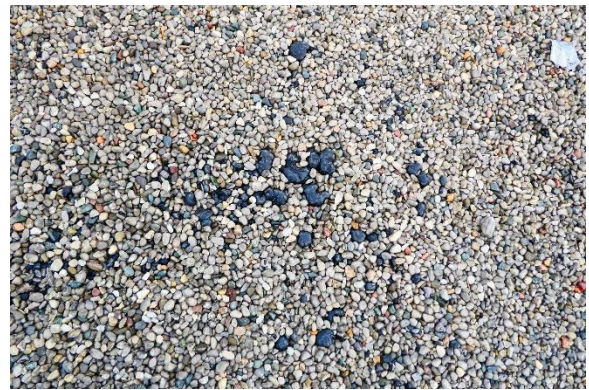
**Photo Exhibit No. 28**  
**Blueberries on roof area.**

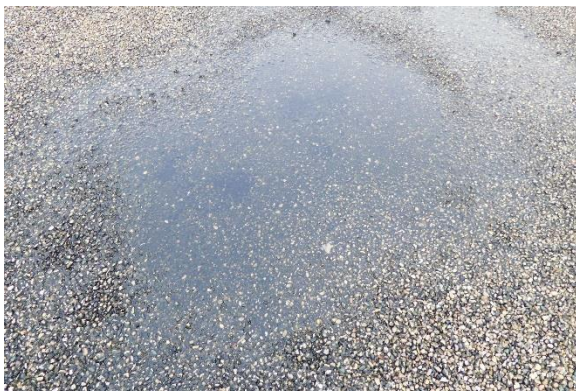
**Photo Exhibit No. 26**  
**Large area of ponding water.**

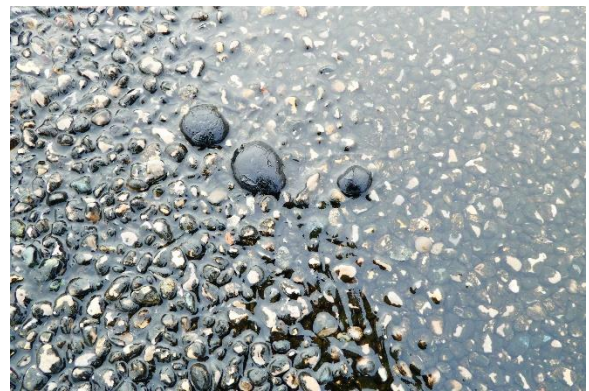
**Photo Exhibit No. 29**  
**Blueberries on roof area.**

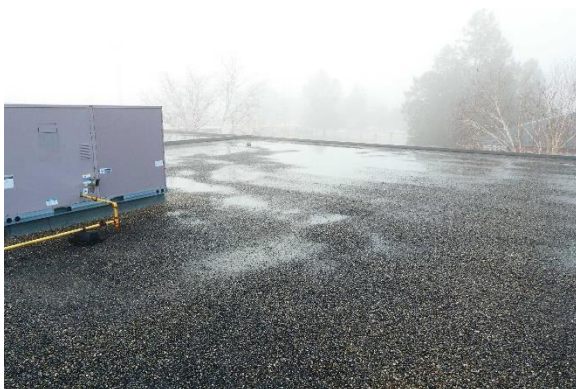
**Photo Exhibit No. 27**  
**Large area of ponding water.**

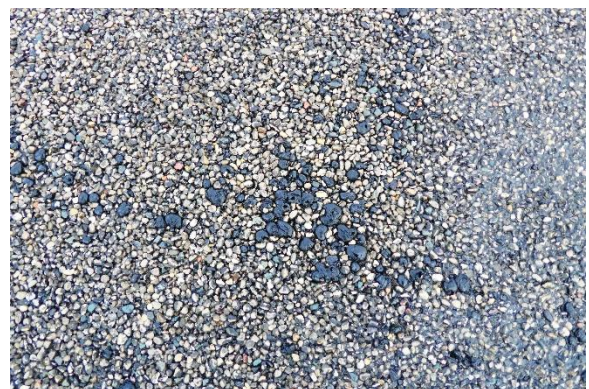
**Photo Exhibit No. 30**  
**Blueberries on roof area.**

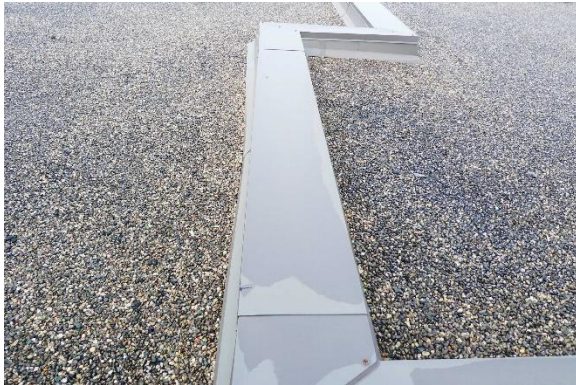
**Photo Exhibit No. 31**  
Nearly flat metal flashing, note standing water.

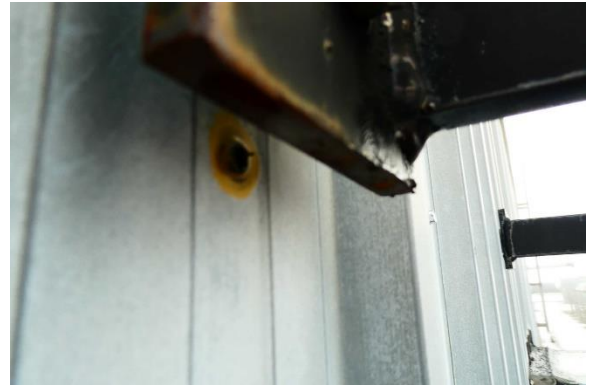
- 4.2.5 Fastener holes and unsealed wall penetrations were observed at the metal high wall location between the lower roof area and the upper roof area. These are a likely source of water infiltration into the building (Reference Photo Exhibit Nos. 33 and 34).
- 4.2.6 Minor amounts of organic growth were observed on the roof at various locations. EXP also observed growth around many of the roof drains on this roof area. This growth can lead to accelerated deterioration of the roof membrane by retaining moisture on the roof membrane/flashings and preventing water from draining off the roof in a timely manner (Reference Photo Exhibit Nos. 35 and 36).

**Photo Exhibit No. 34**  
Fastener hole in metal above recreation center roof.

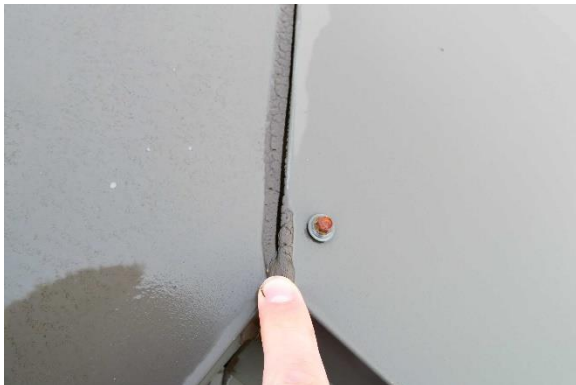
**Photo Exhibit No. 32**  
Failed sealant joint at metal flashing, in location of standing water.

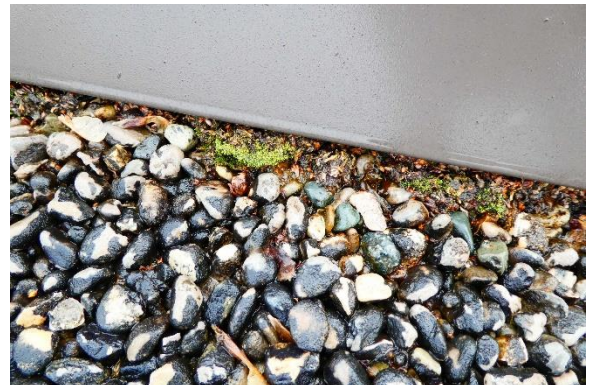
**Photo Exhibit No. 35**  
Organic growth at/beneath metal flashing.

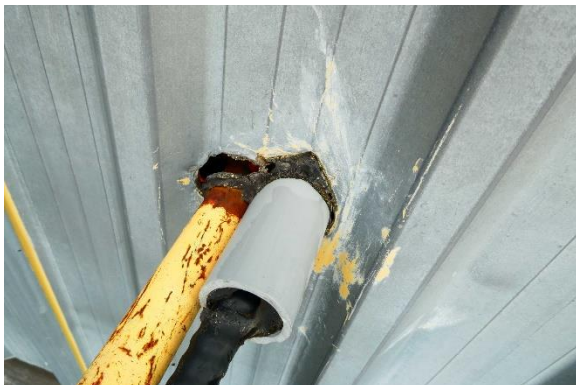
**Photo Exhibit No. 33**  
Large gap in the metal at pipe penetration above recreation center roof.

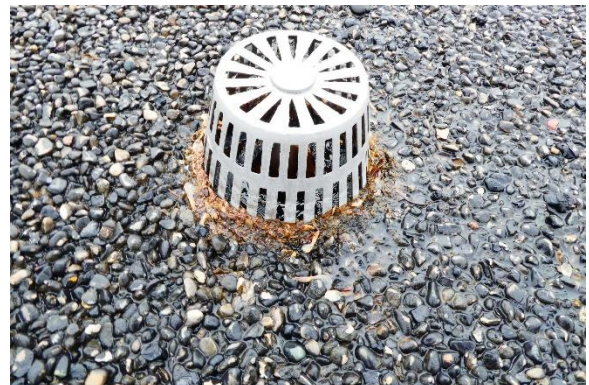
**Photo Exhibit No. 36**  
Growth/debris at drain preventing drainage of water.
