# Municipality of South Huron Exeter Wastewater Treatment Facility Intermittent Sand Filter Investigation and Rehabilitation

South Huron Town Hall - Carling Room, Exeter  
February 5, 2018

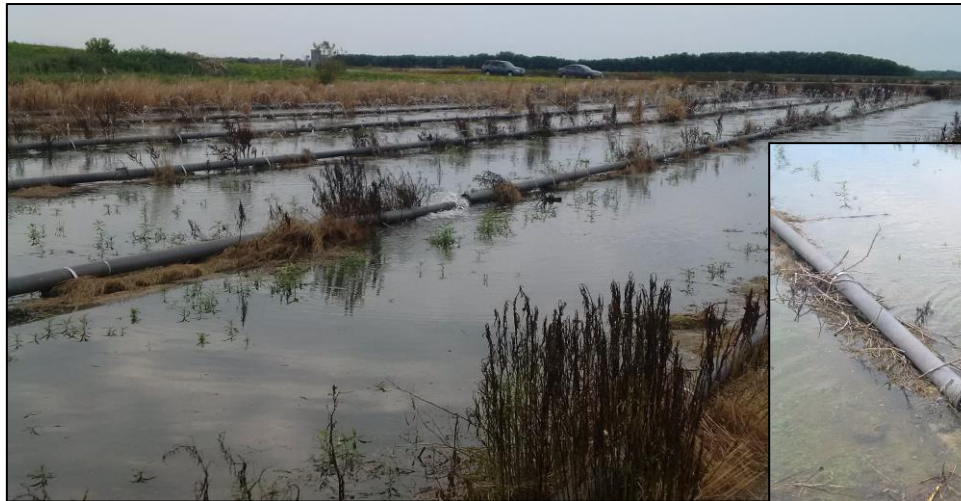
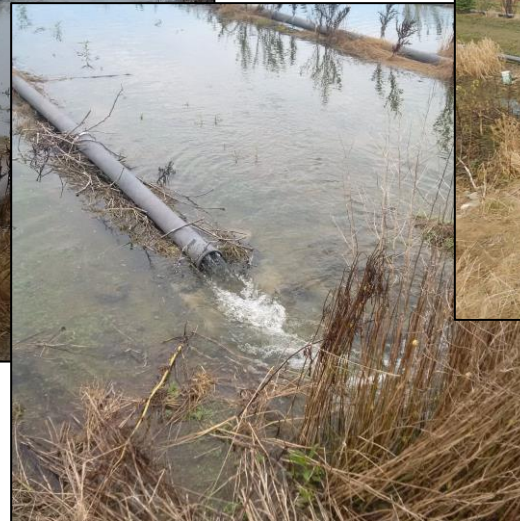
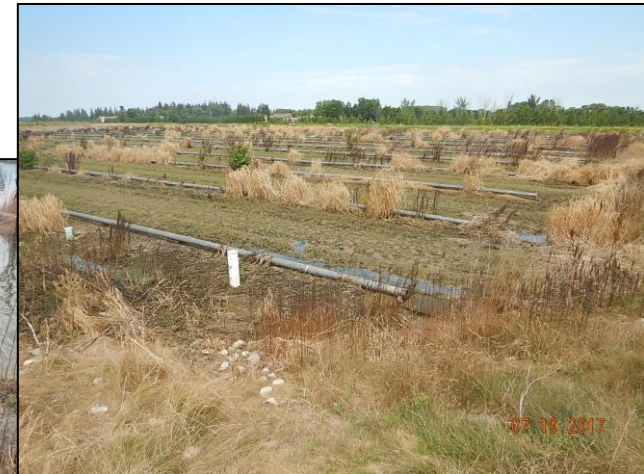
- GM BluePlan staff conducted a site visit on July 19, 2017 in order to inspect and complete a condition inspection and sample collection of the existing sand filter media
- GM BluePlan confirmed South Huron staff comments as significant ponding was observed during operation as well as localized discharges due to pipe joint failures and settlement
- During the site visit, GM BluePlan observed the sand filters in operation as seen below:

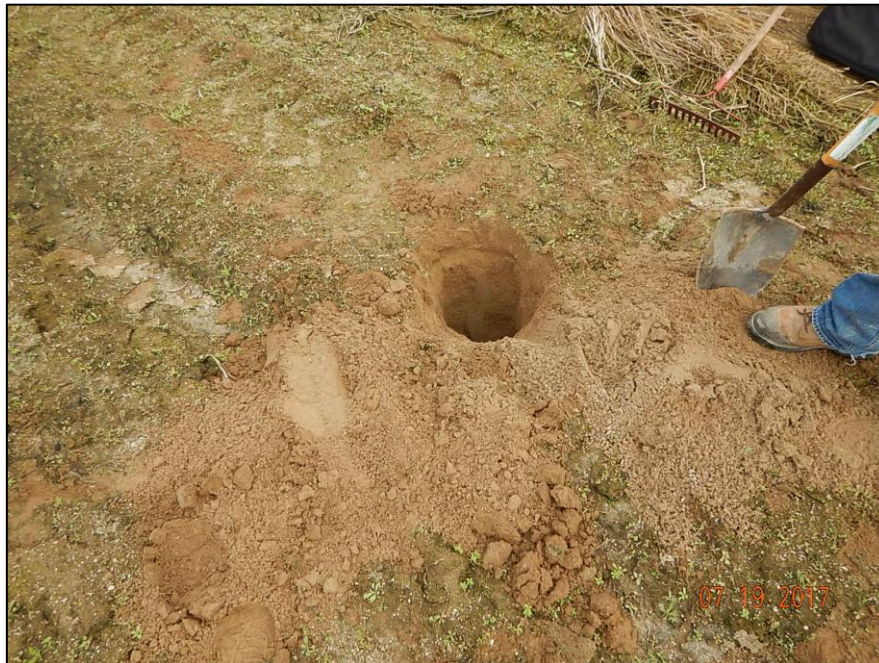
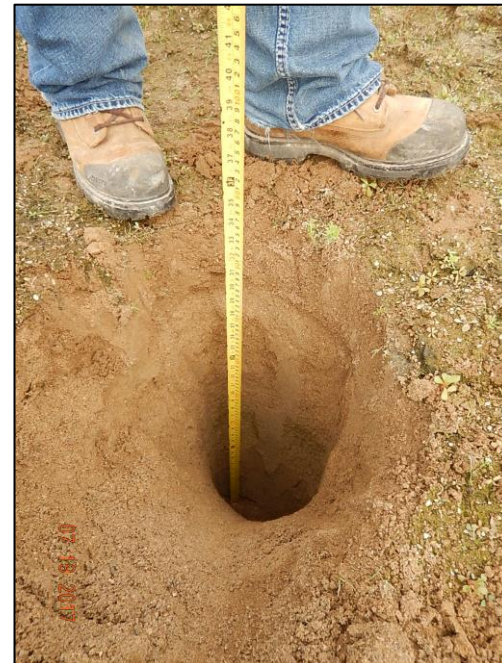
- The results of the sieve analysis tests were compared to the original shop drawings/sand sieve analysis

- Grain size analysis of the samples collected in 2017 vs. the original 2000 shop drawings were compared and the samples collected showed a noticeable variation from the original specifications
- It appears that the grain size of the sand present has become smaller/finer than originally specified and the sand was becoming less uniform and “well” graded
