Garland Canada Inc.

Infrared Thermographic Roof Inspection

Municipality of South Huron – Recreation Centre
94 Victoria Street East
Exeter, Ontario
N0M 1S1

Inspection Date: **May 9, 2022**
Verification Date: **May 13, 2022**
Representative: **Mr. Nick Fedorow**

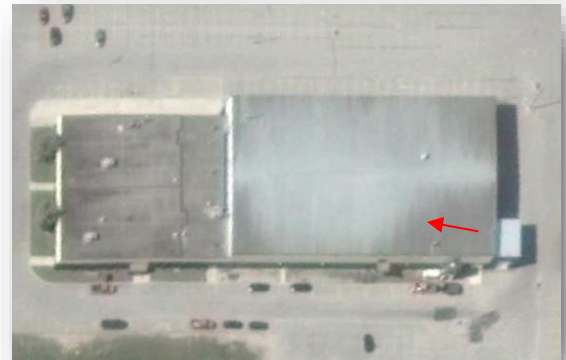
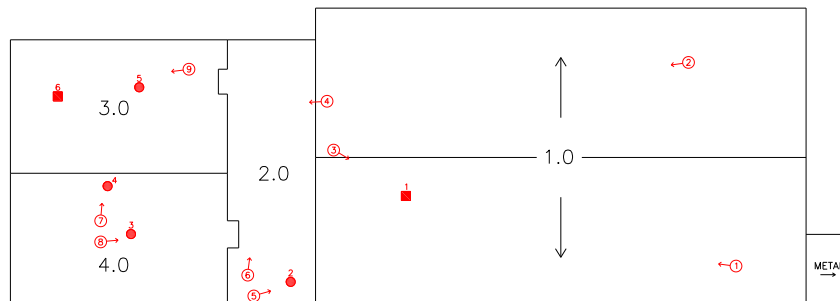
Vantage Point #1

Thermogram looking at typical roof area on Roof Section 1.0.

No suspect anomalies detected on this roof area.

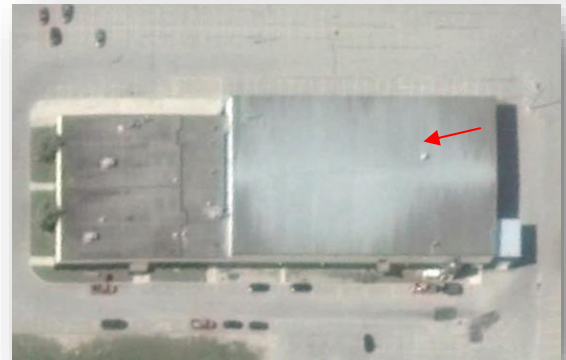
Vantage Point #2

Alternate view Thermogram looking at typical roof area on Roof Section 1.0.

No suspect anomalies detected on this roof area.

Thermal bridging of structural components shown as light coloured lines.

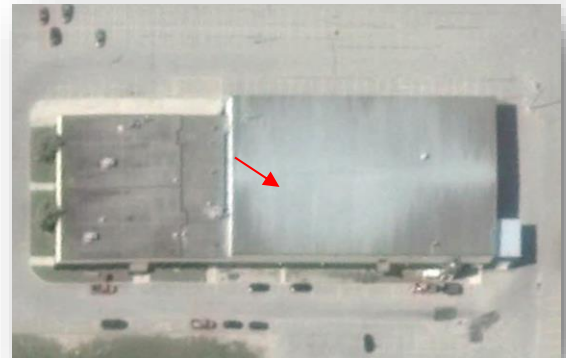
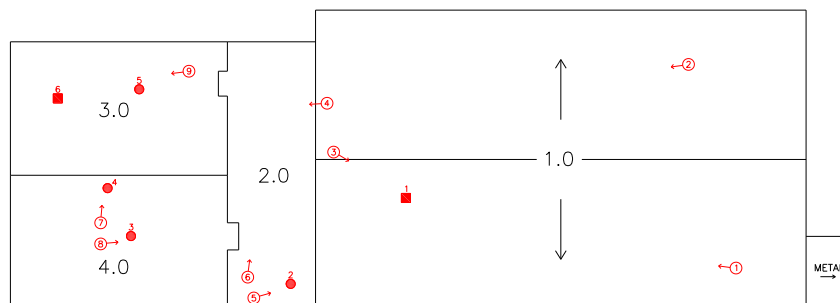
Vantage Point #3

Thermogram looking at typical roof area on Roof Section 1.0.

Verified Core #1 – Dry.

Higher thermal loss noted at this area of roof.

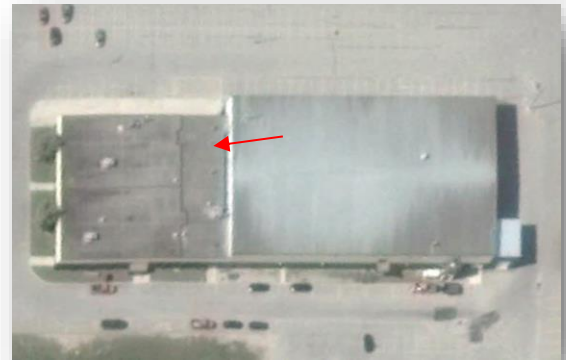
Vantage Point #4

Thermogram looking down from Roof Section 1.0 at typical roof areas on Roof Sections 2.0 & 3.0.

Verified Core #6 – Dry.

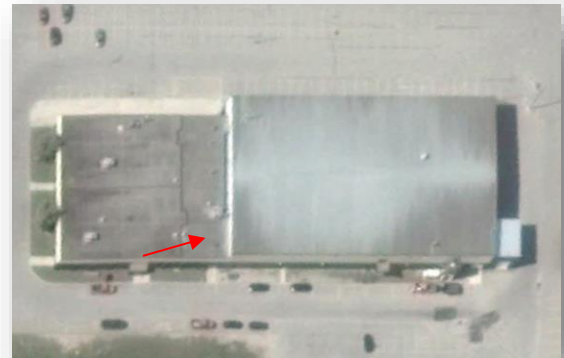
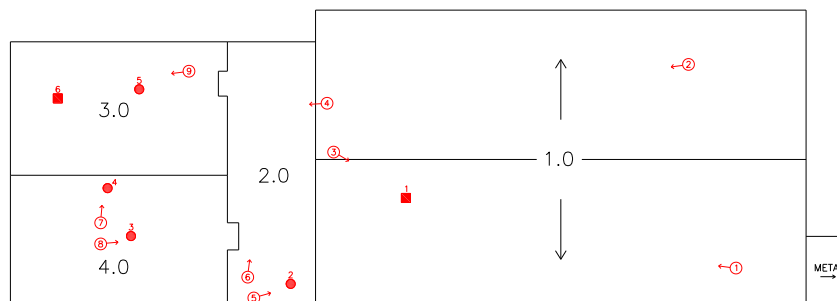
Vantage Point #5

Thermogram looking at suspect anomaly
on Roof Section 2.0.

Verified Probe #2 – Dry.

Drain pan thermal characteristics noted at this location.

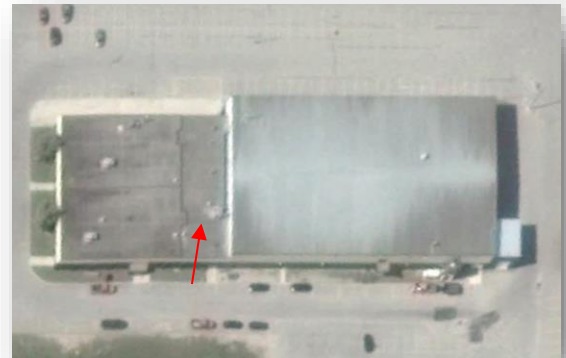
Vantage Point #6

Thermogram looking at typical roof area on Roof Section 2.0.

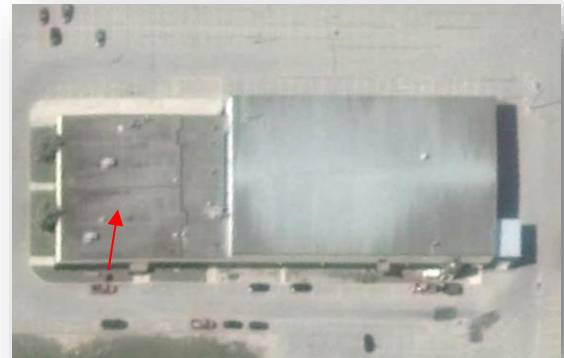
Vantage Point #7

Thermogram looking at suspect anomaly on Roof Section 4.0.

Verified Probe #4 – Dry.

Higher thermal retention caused by excess ballast (gravel) noted at this area.

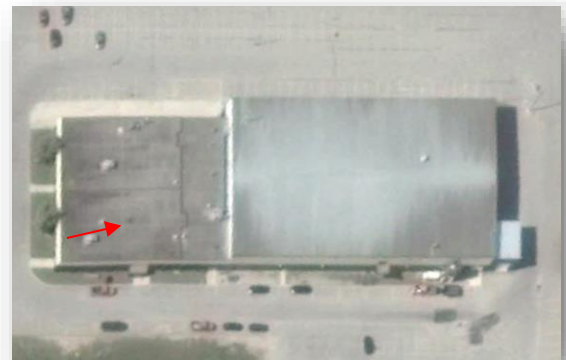
Vantage Point #8

Thermogram looking at suspect anomaly on Roof Section 4.0.

Verified Probe #3 – Dry.

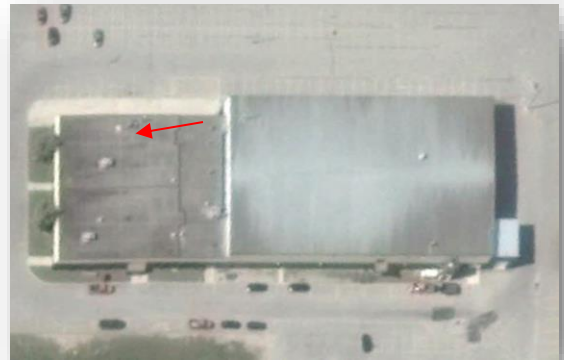
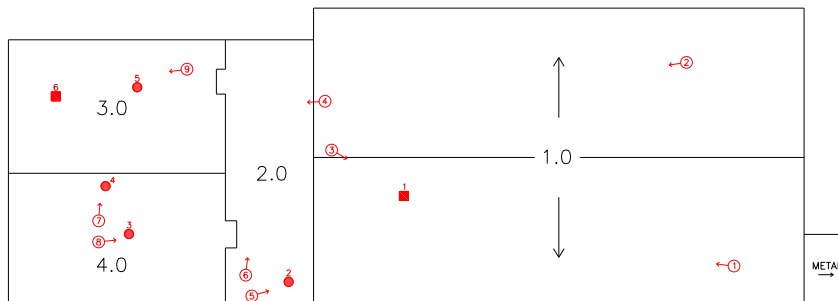
Vantage Point #9

Higher thermal retention caused by excess ballast (gravel) and thicker top pour noted at this area.
